JTB00686NAS1

# TECHNICAL BULLETIN

Poor Ground Contact For Tailgate Wiring Harness

MODEL:	MODEL YEAR:	VIN:	ASSEMBLY PLANT:
I-PACE (X590)	2019	F60001-F67829	Graz (Austria)

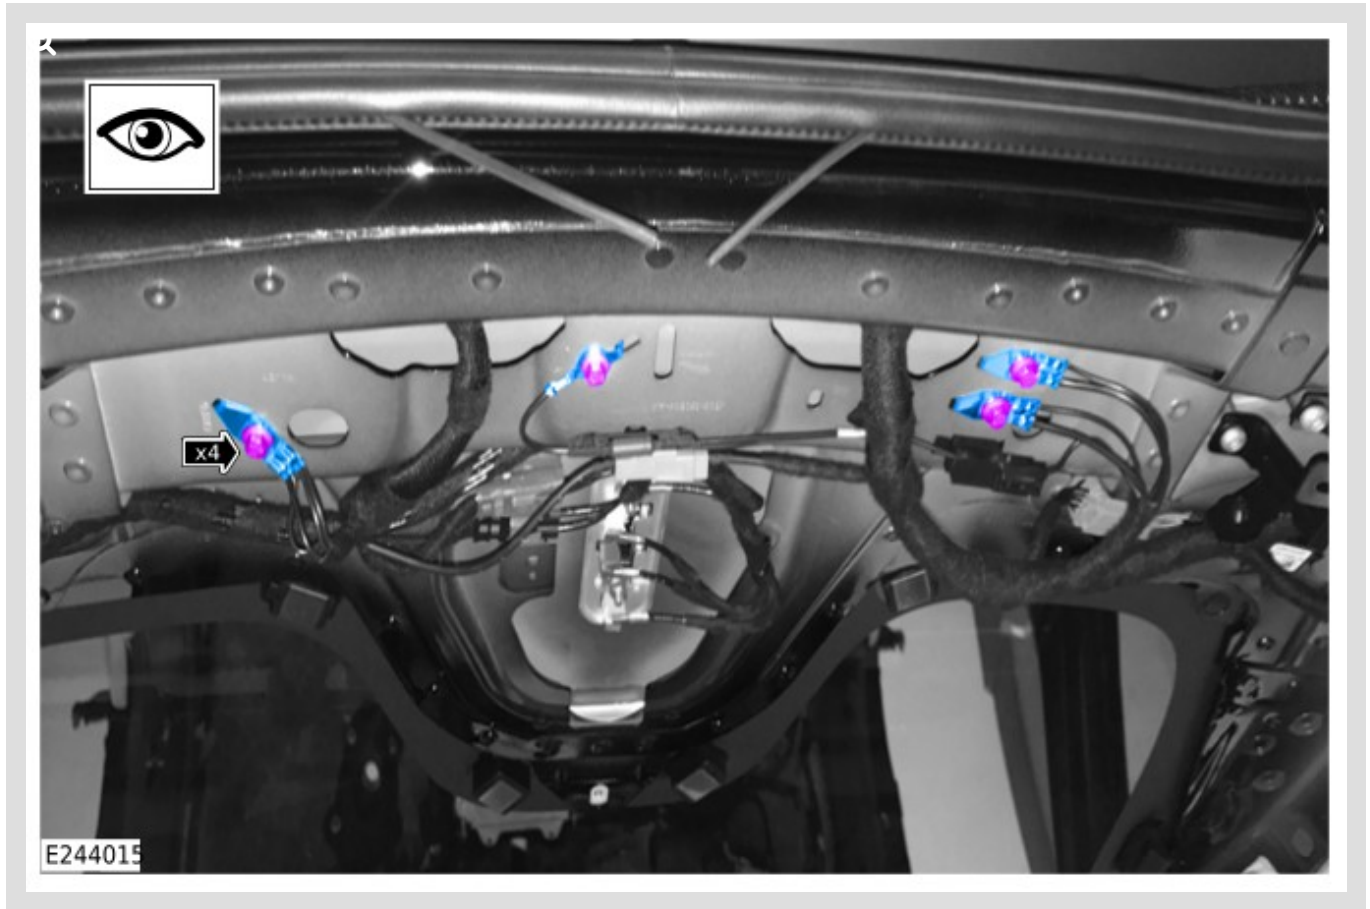
These issues may be caused by ground point contact areas having excess paint and causing a poor contact to ground for the tailgate wiring harness.

Locate the 4 ground points, remove the 4 bolt(s), and reposition the eyelets.
