Technical Service Bulletin

PSS 90 Instrument cluster map is blank after start-up

90 19 14 2054351/2 April 11, 2019. Supersedes Technical Service Bulletin Group 90 number 19-11 dated March 26, 2019 for reasons listed below.

Model(s)	Year	VIN Range	Vehicle-Specific Equipment
A3	2017 - 2019	All	MIB2 High Navigation

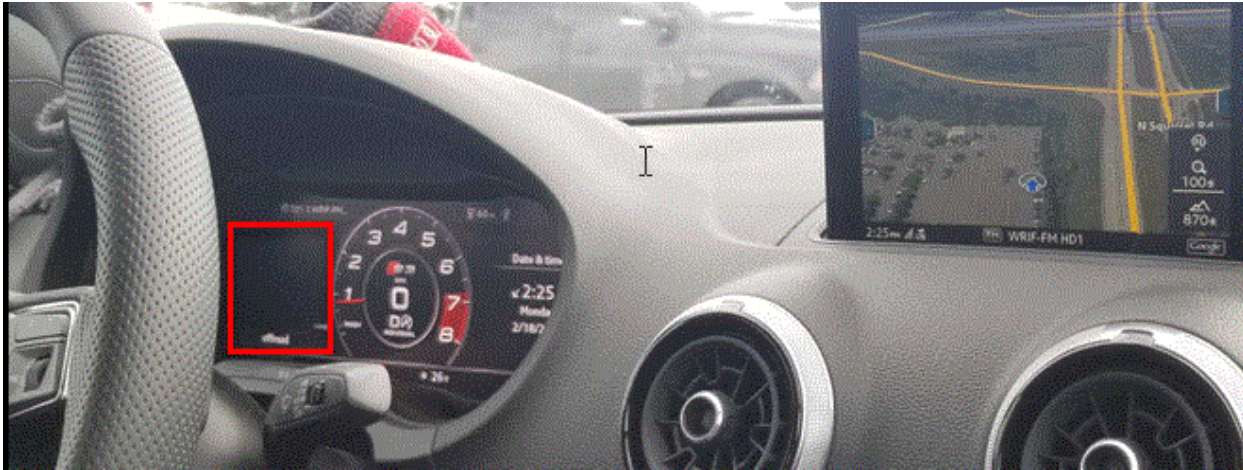
A software bug in the instrument cluster can cause the map not to display if the vehicle is placed in reverse after start-up, then put into park, and the driver's door is opened (Figure 1).

Figure 1. Map section is blank in the instrument cluster display.

1. Diagnose the vehicle according to the instructions listed below. If the customer's vehicle condition matches the condition listed in the *Technical Background* of this PSS TSB, explain to the customer that a solution is forthcoming and that no repairs are necessary at this point.
2. Do not replace any components for this condition since this will not resolve the customer's concern.
3. **Condition verification procedure:**
 - Check/Ask the customer if the map is/was visible in the middle of the speedometer when displayed with big tachometer/speedometer tubes.
 - If so, please follow TSB 2052820: *91 Audi virtual cockpit map section displayed inside the speedometer.*
4. Create a PSS record in the PSS application through the Pending Service Solutions (PSS) link in AccessAudi (under *Related Links >> Service*), or through the Technical Assistance Page in Elsa.
