Service Bulletin

Bulletin No.: 18-NA-020

Subject: Malfunction Indicator Lamp Illuminated with DTC P0300 and/or P0299/P2227 Set

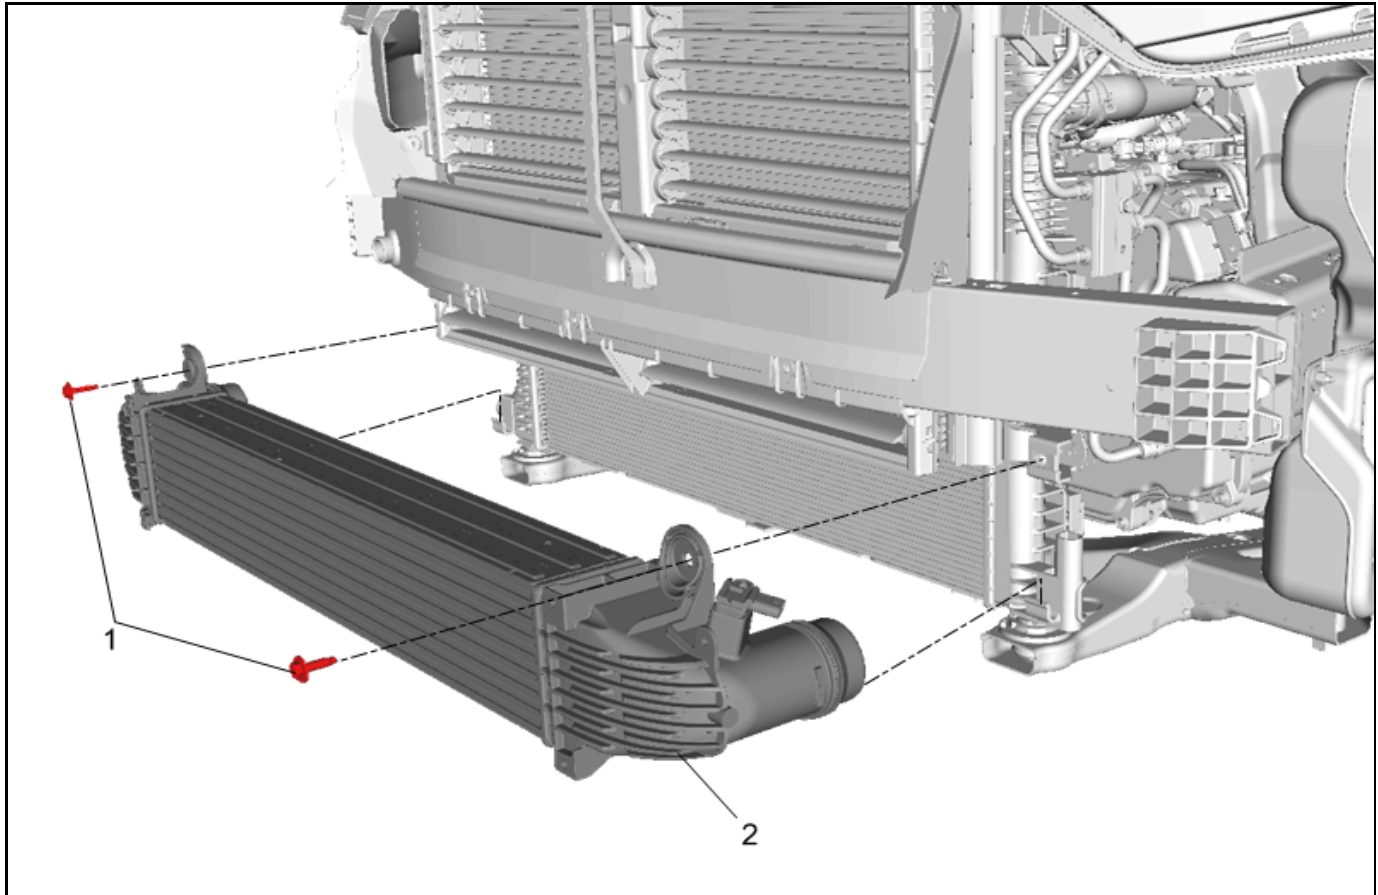
4597334

Involved Region or Country	North America and N.A. Export Regions
Condition	Some customers may comment on a malfunction indicator lamp illuminated. During diagnosis, a technician may find DTC P0299, P2227, or P0300 set/stored.
Cause	This condition may be caused by a moisture build up inside the charge air cooler. Long drives through rainy conditions and/or high humidity conditions (heavy fog) can cause moisture to collect in the charge air cooler. A heavy acceleration can draw moisture into the engine causing DTC P0300. In cold temperatures, ambient and PCV moisture can freeze in the charge air cooler, restricting flow, and causing DTC P0299 and/or P2227.
Correction	Perform a smoke leak test of the charge air cooler, then follow the repair steps in the appropriate Service Procedure below, depending on the build date and vehicle outside temperature experience. Note: Deadener material covering is only to be used in northern states or provinces where temperatures are consistently 20°F/-7°C or less.

1. Perform a smoke leak test of the charge air cooler.

- If a leak is determined, replace the charge air cooler with the newly designed part. Refer to *Charge Air Cooler Replacement* in SI.
- If there is NO leak, but a P0300, P0299 and/or P2227 are present, **AND the vehicle was built ON or BEFORE March 1, 2018**, then replace the charge air cooler with the newly designed part. Refer to *Charge Air Cooler Replacement* in SI.
- If there is NO leak, but a P0300, P0299 and/or P2227 are present, **AND the vehicle was built AFTER March 1, 2018**, refer to SI for further diagnosis.

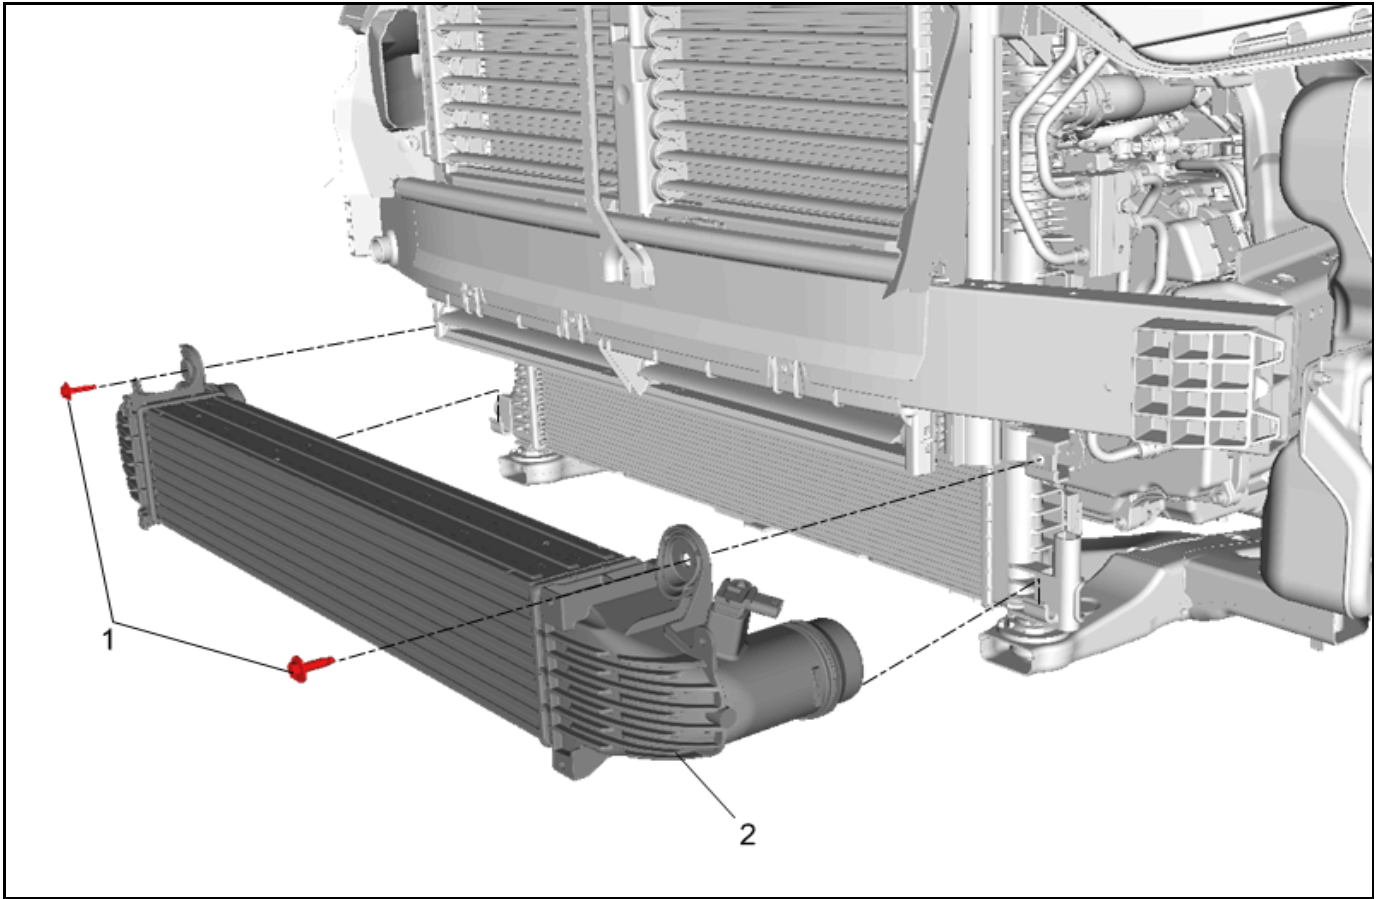
4597334

Important: The newly designed charge air cooler is wider and is NOT compatible with the existing lower baffle on the vehicle. The baffle will need to be replaced to accommodate the larger charge air cooler.

1. Perform a smoke leak test of the charge air cooler.

- If a leak is determined, replace the charge air cooler with the newly designed part. Refer to *Charge Air Cooler Replacement* in SI.
- If there is NO leak, but a P0300, P0299 and/or P2227 are present, **AND the vehicle was built ON or BEFORE January 5, 2019**, then replace the charge air cooler with the newly designed part. Refer to *Charge Air Cooler Replacement* in SI.
- If there is NO leak, but a P0300, P0299 and/or P2227 are present, **AND the vehicle was built AFTER January 5, 2019**, refer to SI for further diagnosis.
