Service Bulletin

Bulletin No.: 18-NA-182

Subject: Information on Water Leaks in Rear Cargo Area, Rear Compartment Well, Possible Loss of Chime and/or Radio Functions

Brand:	Model:	Model Year:		VIN:		Engine:	Transmission:
		from	to	from	to		
Chevrolet	Bolt EV	2017	2019			All	All
Opel	Ampera-e	2017	2019			All	All

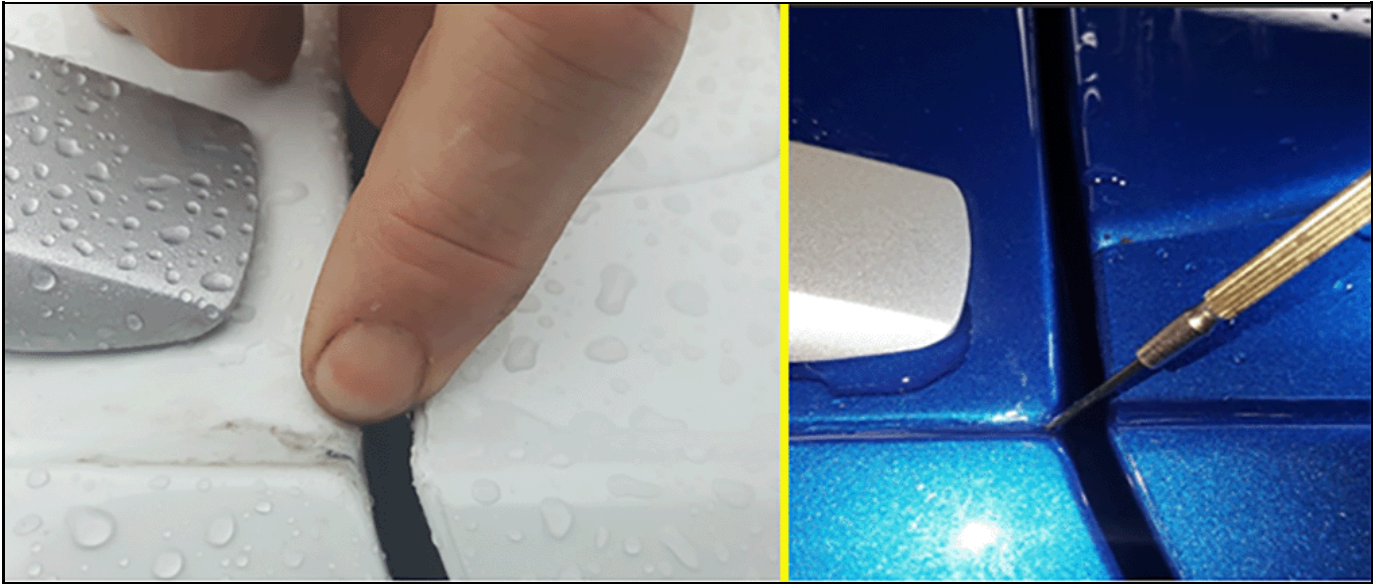
5074583

Pinhole in Roof Drip Rail

Checking the locations noted below, verify the condition. Then as necessary, reposition/seal parts and/or repair the leak path and apply the appropriate sealant, referencing *Body Waterleak Repair* in SI.

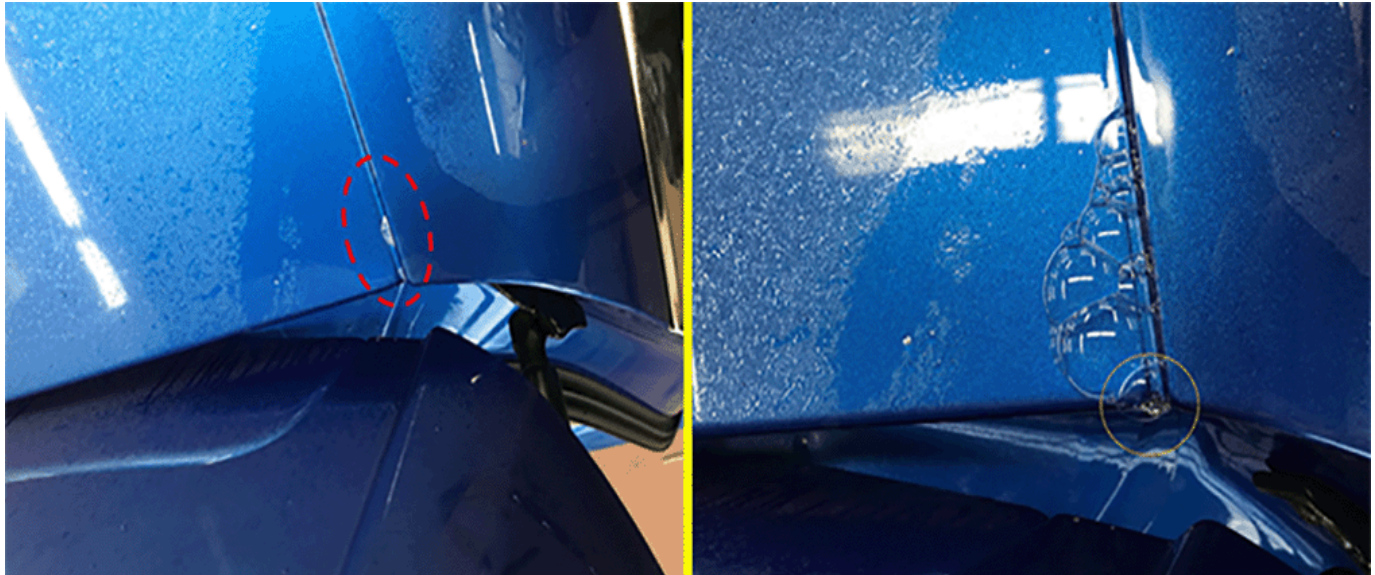
5249870

Note: In some cases, larger voids have sometimes been found in the same rear roof seam area noted above. Test the roof panel seam line by following the recommended steps below:

1. Lower the rear of the headliner to gain access to the roof seam. Refer to *Headlining Trim Panel Replacement* in SI.
2. Spray a soapy solution on top of the roof at the seam line.
3. Using a long nose spray nozzle, spray air on the bottom of the roof seam between the headliner and roof.
4. If air bubbles are visible on the top of the roof seam, repair using an appropriate body shop sealant and if necessary, touch up with the appropriate color paint.
5. Reinstall the headliner. Refer to *Headlining Trim Panel Replacement* in SI.

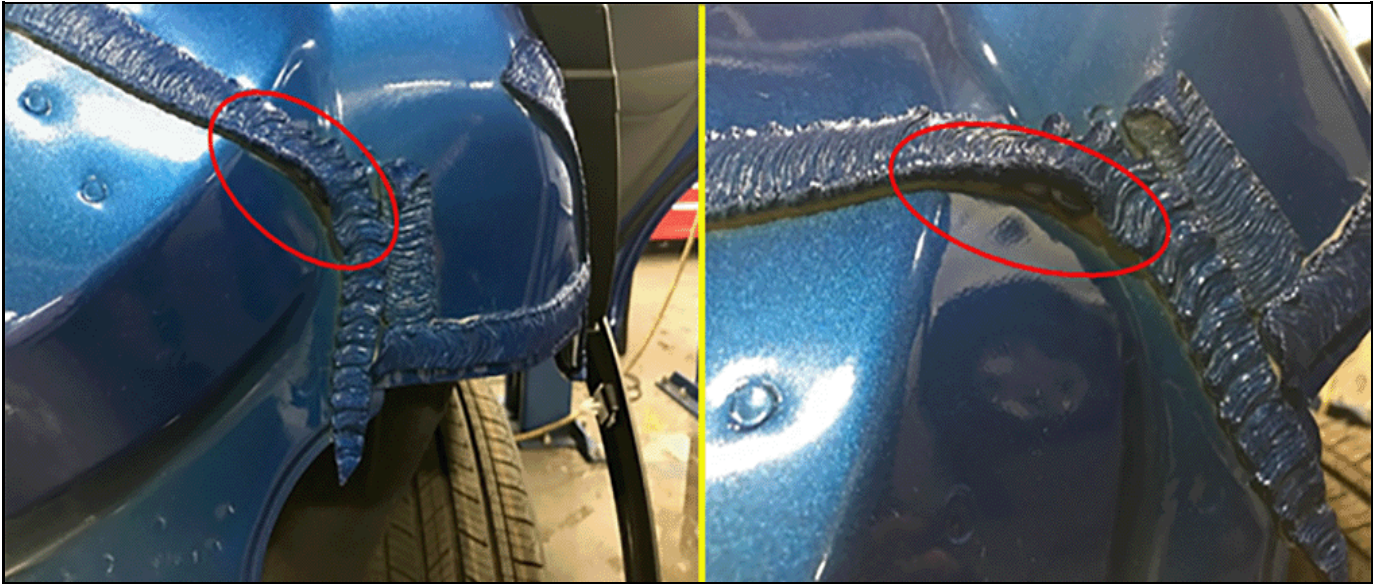
5074590

Body Sealer Void Behind Rear Fascia

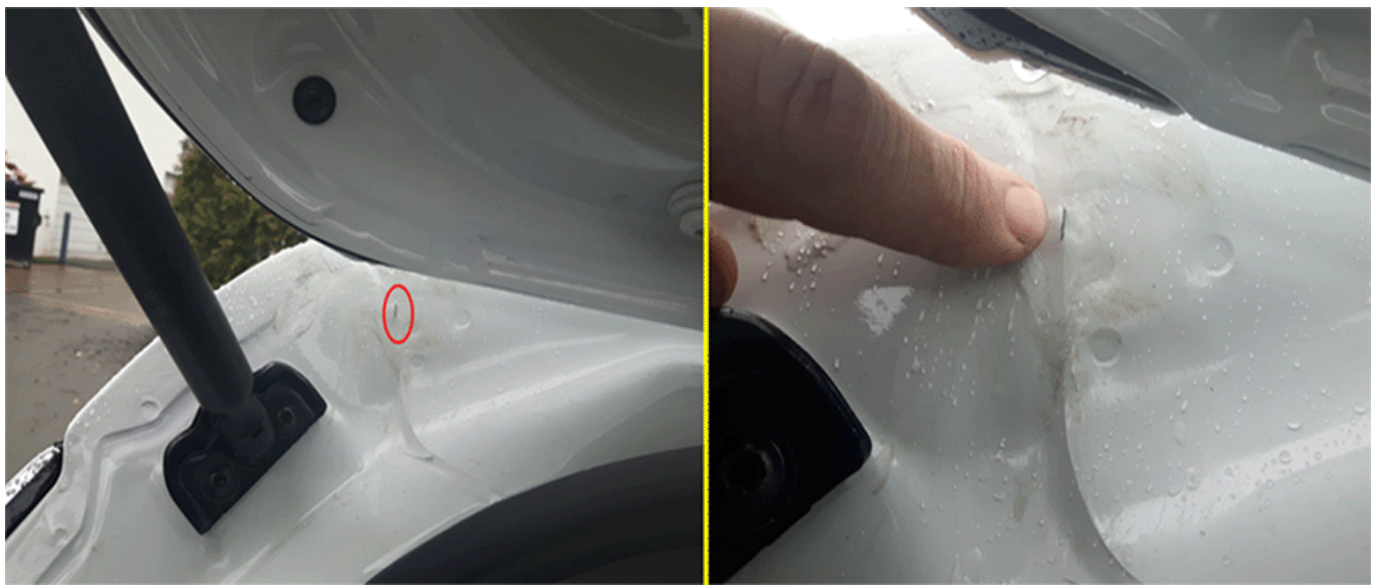
5074602

Body Sealer Crack Near Left Liftgate Shock Bracket

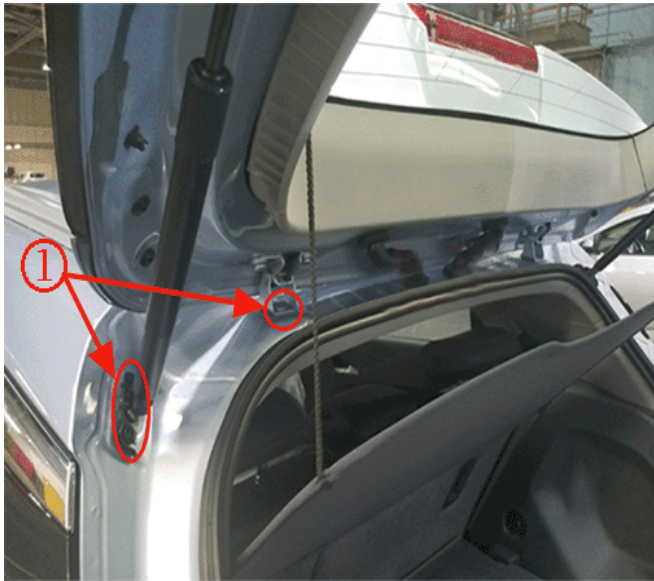
5075032

Water Leak at Threads of Liftgate Hinge and Shock Retaining Bolts.

Note: Apply sealer to bolt threads (1).

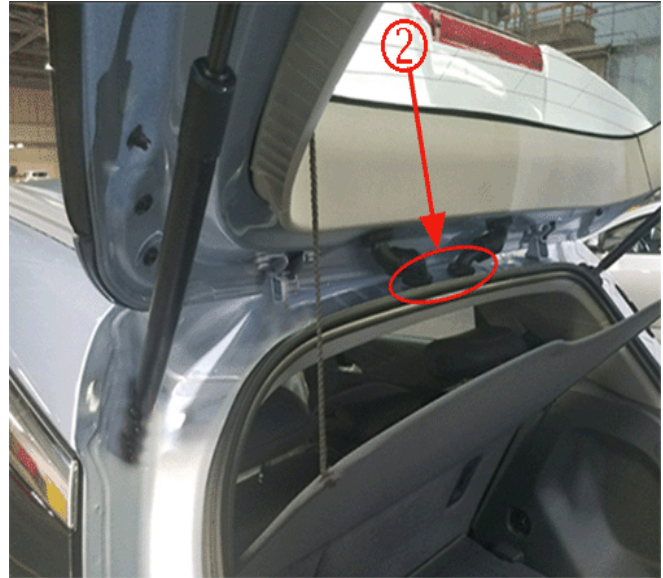
5075040

Water Leak at Liftgate Wiring Harness Grommets.

Note: Reposition grommets so they are fully seated (2).
