Service Bulletin

Bulletin No.: 19-NA-055

Subject: Accessory Front Floor Liner Warped, Bent Inward

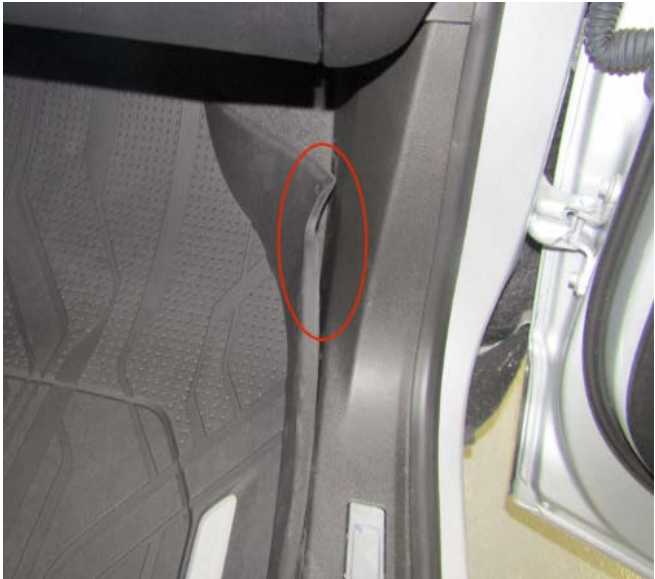
| Condition | <p style="text-align: right; font-size: small;">5280096</p> <p>Customer may comment on one, or both, front floor liners that being warped or bent inward.</p> |
| Cause | The cause of the condition may be a wire harness behind the garnish trim which pushes the trim inboard, creating a gap to the floor liner. |

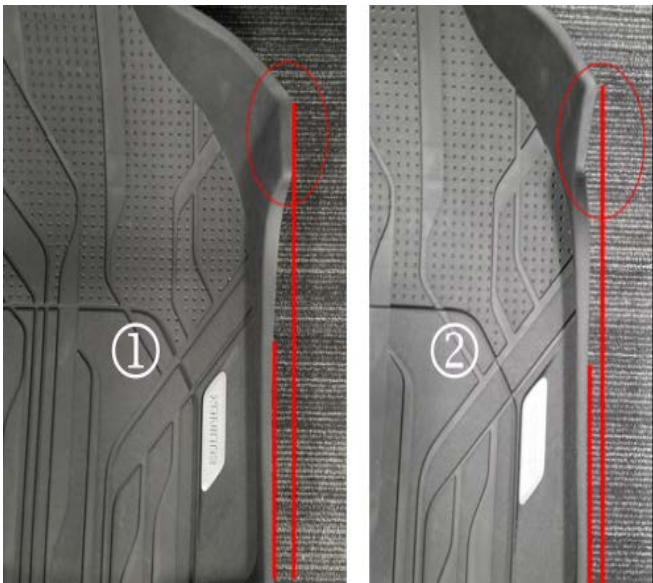
Note: Examples of a good (1) and bad (2) floor liner are shown in the graphic above.

First inspect the affected floor liner(s) to verify if it is a candidate for the trimming repair. Remove the floor liner(s) from the vehicle and lay flat on a clean surface:

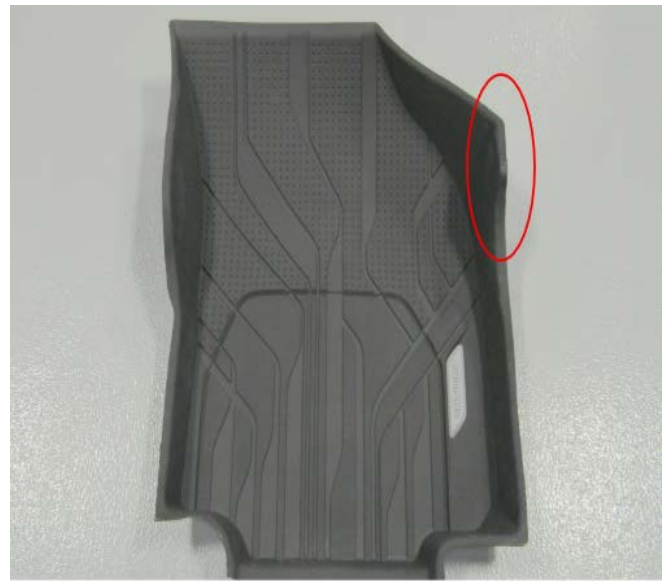
- If the outboard corner, shown circled above, returns to normal shape, the liner can be trimmed. Proceed ahead to the repair procedure below.

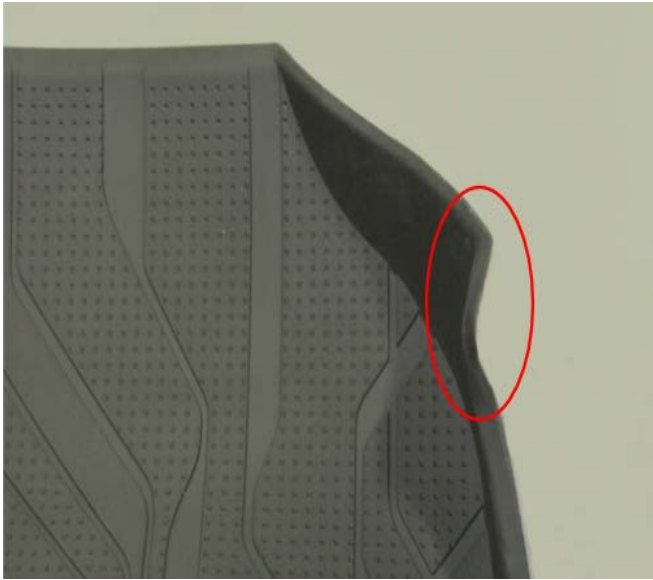
5280118

- If the outboard corner, remains warped or has taken a set, the trimming repair will not improve the condition and it would be necessary to replace the floor liner.
