# **Technical Service Bulletin**

SUBJECT:			No:	TSB-19-42A-001	
NOISE FROM G	DATE:	March 2019			
CLOSING TAILGATE				MODEL: See below	
CIRCULATE TO:	[] GENERAL MANAGER	[X] PARTS MANAGER		[X] TECHNICIAN	
[X] SERVICE ADVISOR	[X] SERVICE MANAGER	[X] WARRANTY PROCESSO	DR	[] SALES MANAGER

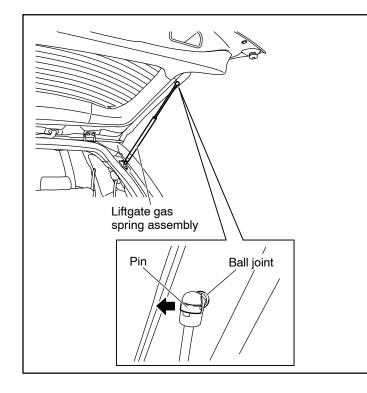
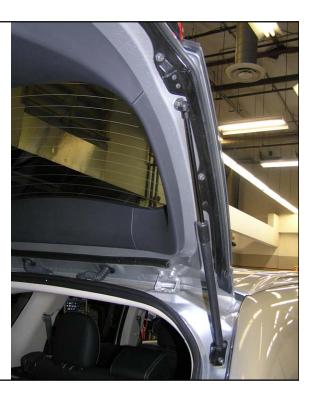
A customer may report noise generating from the tailgate gas springs when opening and closing the tailgate (on vehicles with either non-electric or electric tailgates). This noise may occur when the high sliding friction of the oil seal of the tailgate gas springs causes a stick-slip condition during expansion or contraction. Starting with vehicles produced after October 3, 2018, the oil seal of the tailgate gas spring has been changed to a low friction type.

1. Remove BOTH gas springs from the tailgate.

## NOTE: Even if the noise complaint is only for one side, the gas springs for <u>both</u> sides must be replaced at the same time (RH side shown below for example).
