# TECH TALK

Volume 248 - March 2019

## Vehicle Technical Info

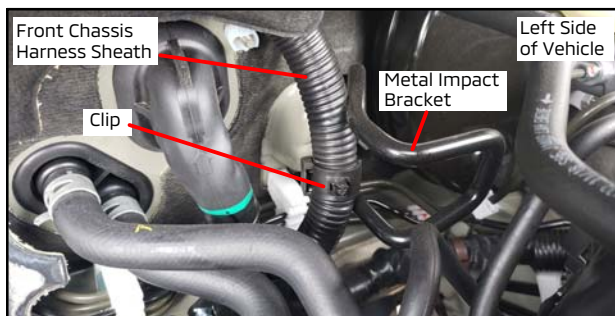
The clip on the wiring harness sheath (shown in the photo below) is used by the supplier for all markets, and does **NOT** attach to any brackets in the vehicle. This is by design – **no repairs are required.**

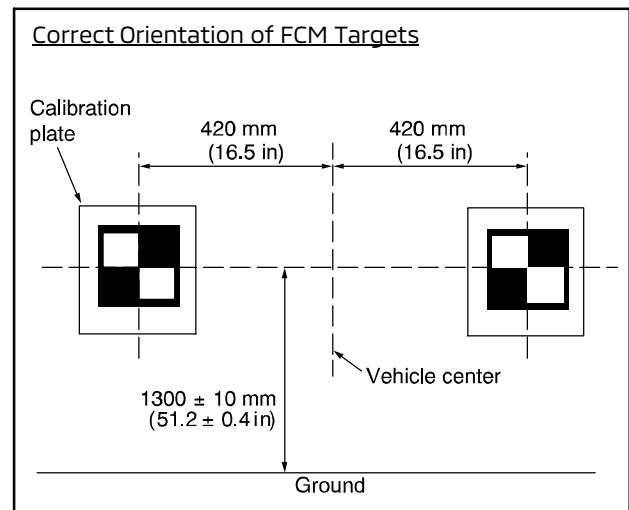
When calibrating the Forward Collision Mitigation (FCM) sensor, located at the top of the windshield, you must position the FCM targets correctly, as shown below.

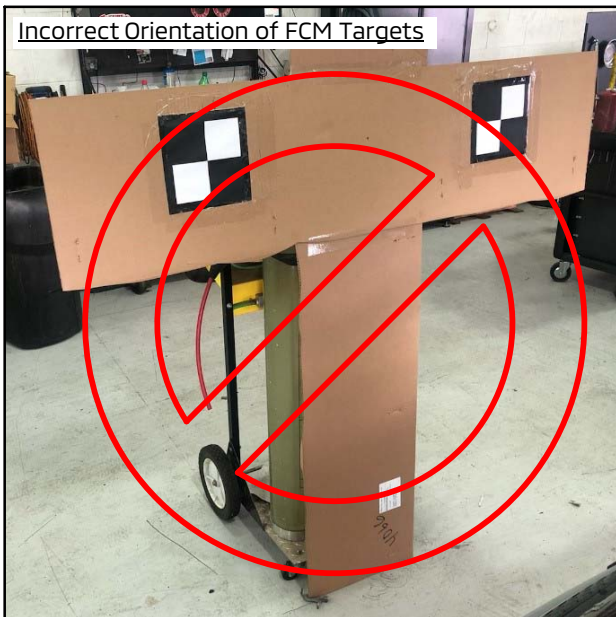
If the targets are not positioned correctly, as shown in the following photo, calibration of the FCM sensor will be unsuccessful.

For detailed instructions on calibrating the FCM sensor, refer to Group 54A in the applicable vehicle Service Manual.

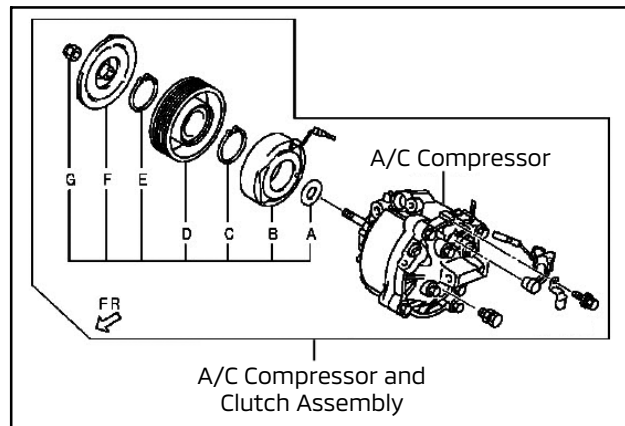
Should an A/C compressor need to be replaced, dealers should utilize the most cost effective repair option. Most of the time, the A/C compressor is available without the clutch assembly and can be purchased for less expense than the A/C compressor and clutch assembly (Outlander Sport/RVR shown below for example).
