SERVICE BULLETIN

| Classification: EL18-005b | Reference: NTB18-041b | Date: March 19, 2019 |

2017-2018 ROGUE, ROGUE HYBRID, AND ROGUE SPORT; FALSE ACTIVATION OF AEB, FEB, OR FCW

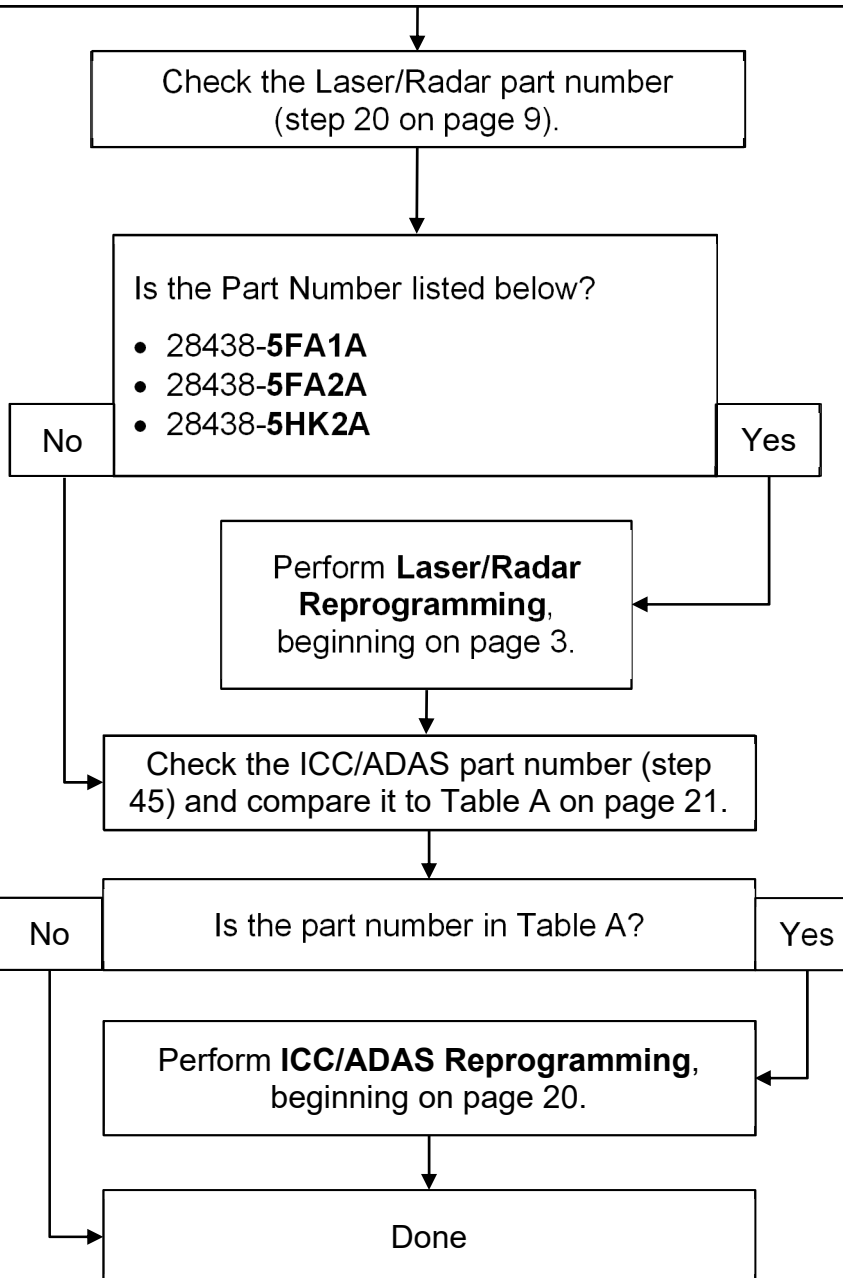
Repair Overview

The following system(s) falsely activated or the customer reports false activation in an Applied Vehicle:

- AEB (Automatic Emergency Braking);
- FEB (Forward Emergency Braking);
- FCW (Forward Collision Warning)

NOTE: If reprogramming is not performed, refer to the Electronic Service Manual (ESM) for further diagnostic information.

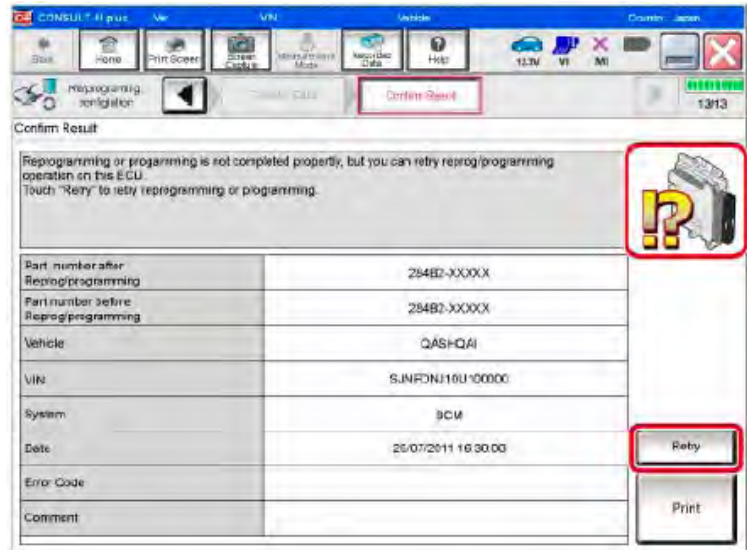
Figure 21

If reprogramming does not complete and the “!?” icon displays as shown in Figure 21:

- Check battery voltage (12.0 - 15.5 V).
- Ignition is ON, engine OFF.
- External Bluetooth® devices are OFF.
- All electrical loads are OFF.
- **Select retry and follow the on screen instructions.**
- **“Retry” may not go through on first attempt and can be selected more than once.**

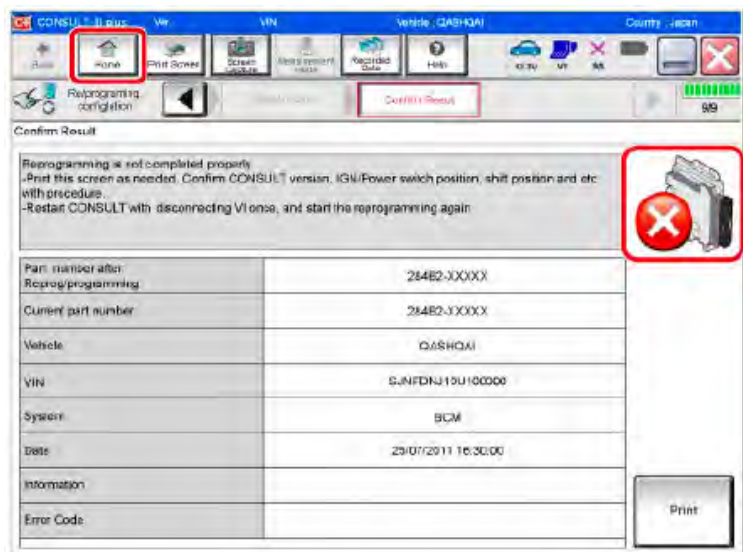
Figure 22

If reprogramming does not complete and the “X” icon displays as shown in Figure 22:

- Check battery voltage (12.0 - 15.5 V).
- CONSULT A/C adapter is plugged in.
- Ignition is ON, engine OFF.
- Transmission is in Park.
- All C-III plus / VI cables are securely connected.
- All C-III plus updates are installed.
- **Select Home, and restart the reprogram procedure from the beginning.**

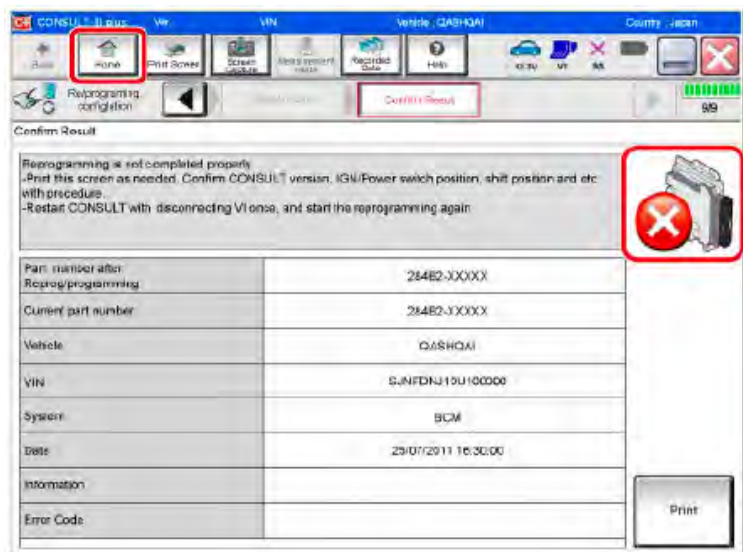
Figure 31

If reprogramming does not complete and the “X” icon displays as shown in Figure 31:

- Check battery voltage (12.0 - 15.5 V).
- CONSULT A/C adapter is plugged in.
- Ignition is ON, engine OFF.
- Transmission is in Park.
- All C-III plus / VI cables are securely connected.
- All C-III plus updates are installed.
- **Select Home, and restart the reprogram procedure from the beginning.**
