Title Volvo Chassis - Windshield Wiper Function Inoperative In Intermittent Mode **ONLY**;  
Wiper Intermittent Setting Not Working - **Model Year 2018 to 2020**

**Volvo Model** VNL , VNR , VNX , VAH , VHD

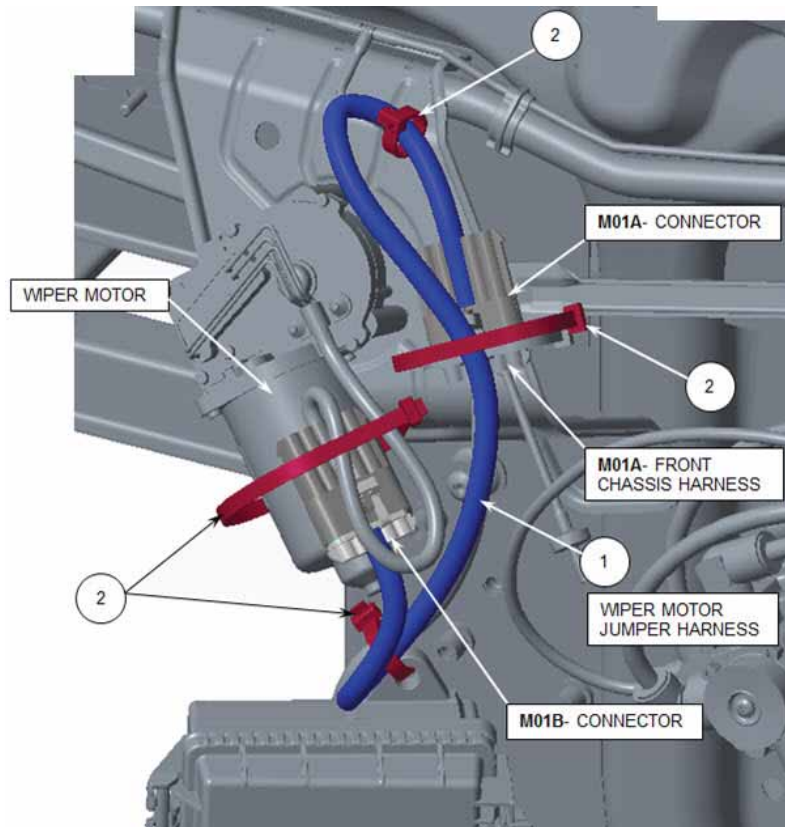
**Cause** For vehicles model year 2018 to 2020, the windshield wipers may not function when the intermittent setting is selected. This condition may result from wiper motor contact with the motor slip ring, resulting in the current from the Light Control Module (LCM) to the Wiper Motor to be too low.

1. Order Harness Jumper 23522546.
2. Install the jumper harness as shown in the picture below.
