INSTRUMENT CLUSTER AND ONBOARD COMPUTER INTERMITTENTLY INOPERATIVE

G05 (X5 Sports Activity Vehicle)	G07 (X7 SAV)	G14 (8 Series Convertible)	G15 (8 Series Coupe)
G20 (3 Series Sedan)	G29 (Z4 Roadster)

Produced from July 1, 2018 thru March 30, 2019

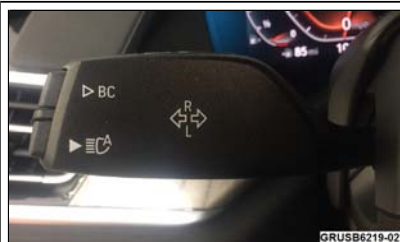
Instrument Cluster (KOMBSP18) functions are intermittently inoperative, including:

- On-board Computer (BC) button on turn signal stalk (BC button shown at left)
- Radio displays
- Menu button
- Turn signal displays
- Arrows on multifunction steering wheel
- MFL thumbwheel control (shown at left)

Program/encode the vehicle to Integration level (I-level) S18A-19-07-510 or higher.

1. Perform a diagnostic quick test to obtain the I-level.
2. If the I-level is S18A-18-11-5xx or lower, program the vehicle to I-level S18A-19-07-510 or higher.

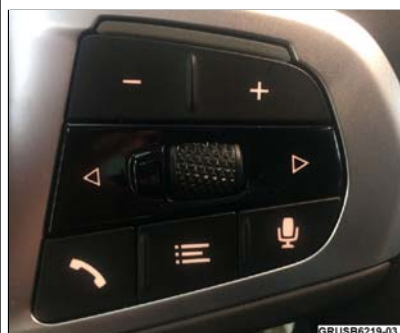
Additionally, the audio source, radio station, or music track cannot be changed using the MFL.
