## Field campaign

<b>Topic</b>	Front camera parameters (SC19/04)
<b>Market area</b>	Bentley: worldwide (2WBE),Hongkong-Macau (5HK)
<b>Brand</b>	Bentley
<b>Transaction No.</b>	2053347/1
<b>Campaign number</b>	EB18
<b>Note</b>	
<b>Type</b>	
<b>US code</b>

### Bentayga

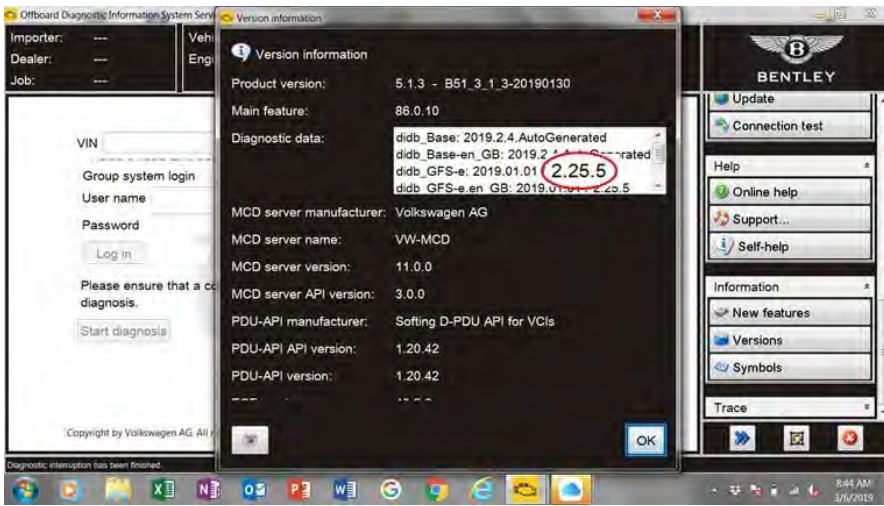
IMPORTANT: Check the current version of ODIS on your VAS tester. Select the **Information** menu on the ODIS home screen and check the **Brand version** (highlighted below).

If the **Brand version** is **2.25.5** a Hotfix is required to be installed on the tester before carrying out the repair, follow the [Installing Hotfix](#) section of this document.

If the **Brand version** is **2.25.6** or higher a Hotfix is not required, proceed straight to the [Parameter settings](#) section of this document.

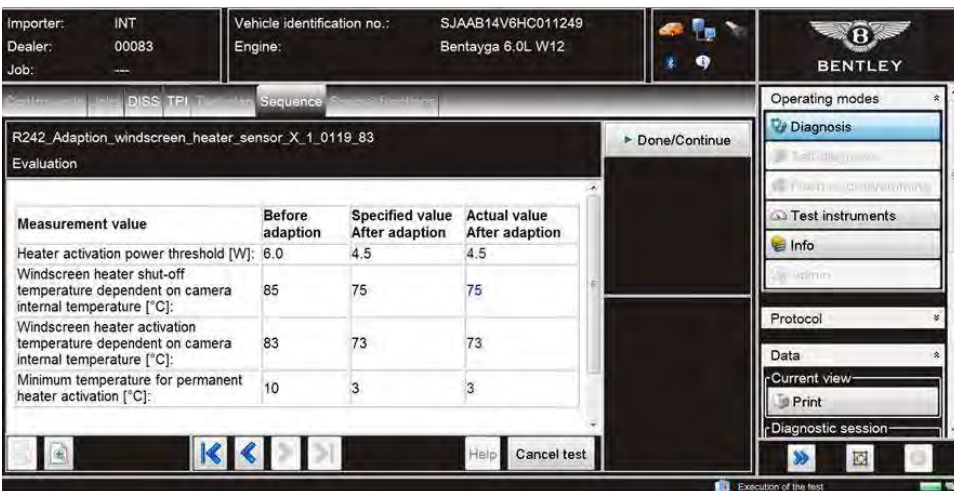
Figure 6

On a limited number of Bentayga vehicles, the heating parameters for the front camera may have been set incorrectly.

Now select and run the test, the heating parameters for the front camera will be adjusted. Ensure the new values in the 'Actual value after adaption' column are stored exactly as below (Figure 6).
