# **Technical product information**

Торіс	Bentley Dynamic ride system fault within the DIP - DTC C129600 logged		
Market area	Bentley: worldwide (2WBE),Hongkong-Macau (5HK)		
Brand	Bentley		
Transaction No.	2054300/1		
Level	EH		
Status	Approval		
Release date

### Bentley Dynamic ride system fault within the DIP - DTC C129600 logged

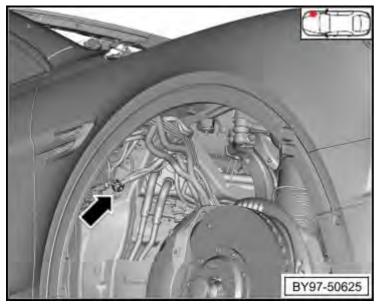
#### Figure 2

- Remove the right hand front wheelarch liner Refer to Repair manual Rep. Gr 66
- Referring Figure 2 and Repair manual wiring diagrams locate earth point number 13

3) With care - Remove the earth point fixing - Carry out the following checks

- Check for any paint/dirt residue on the actual earth point Use suitable abrasive material to remove any paint or dirt
- Check the earth cable terminal to ensure it is free from paint or dirt Use suitable abrasive material to remove any paint or dirt
- Refit the earth cable terminal and fixing nut

• Torque the earth point fixing nut to 9 Nm

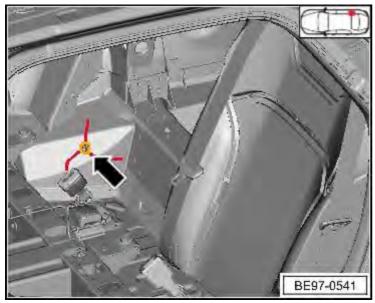
### Figure 3

# IMPORTANT: Figure 3 shows the earth point (730) on 4/5 seat specification vehicles - Figure 4 shows the earth point location (53) for 7 seat specification vehicles

• 4 and 5 seat variants - Referring Figure 3 and the Repair manual wiring diagrams locate earth point number 730

5) With care - Remove the earth point fixing - Carry out the following checks

- Check for any paint/dirt residue on the actual earth point Use suitable abrasive material to remove any paint or dirt
- Check all earth cable terminals to ensure they are free from paint or dirt Use suitable abrasive material to remove any paint or dirt
- Refit the earth cable terminals and fixing nut
- Torque the earth point fixing nut to **3Nm + 45°**
- Erase DTC C129600 using a suitable diagnostic tool
- Carry out a short road test

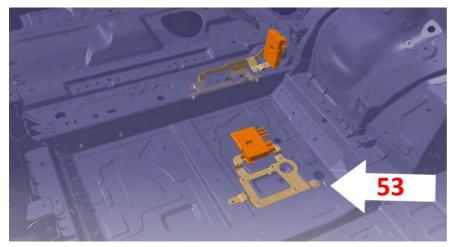
### Figure 4

• 7 seat variants - Referring Figure 4 - Locate earth point number 53 (Situated to the right hand side of the rear floor panel) to gain access remove the rear bench assembly - 3rd row - Refer to Repair manual Rep. Gr 72 Rear bench seat assembly - 3rd row (7 seat) - to remove and fi
