Technical Service Bulletin

Mazda North American Operations
Irvine, CA 92618-2922

Subject: CHECK ENGINE LIGHT ON WITH DTC P2096:00	Bulletin No.: 01-011/19
	Last Issued: 04/15/2019

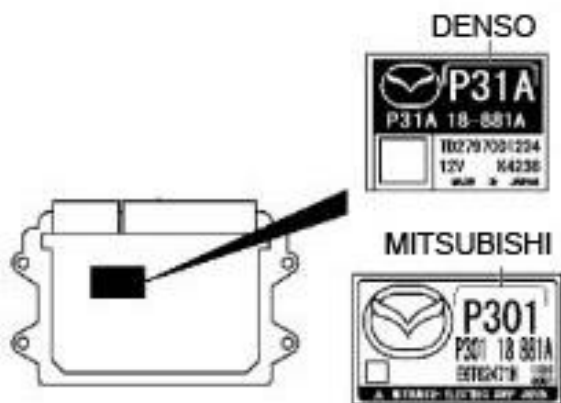
PCM Identification

NOTE: This concern occurs only on vehicles with PCMs manufactured by Mitsubishi.

Due to improper control logic of the PCM, a false error may be detected. To eliminate this concern, the PCM software has been modified.

1. Verify the customer concern.
2. Using the image above, verify the PCM is manufactured by Mitsubishi.
3. Reboot the IDS to clear memory before reprogramming.
4. Using IDS **113.01** or later software, reprogram the PCM to the latest calibration (refer to “Calibration Information” table) by following the “Module Reprogramming” procedure.
