Technical Bulletin

26 19 02 April 24, 2019 **2028415** Supersedes Technical Bulletin 26-17-02 dated October 10, 2017 to update warranty labor operation number due to SAGA changes.

MIL ON, Secondary Air DTCs P2431, P2432, P2433 Stored in ECM Fault Memory

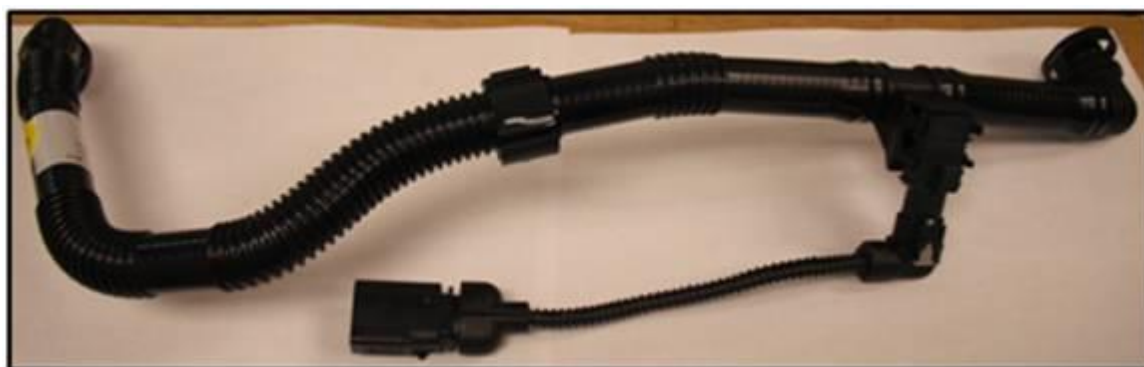
Sensor Service-kit Part Number: 07K 198 125

Original components were manufactured as an assembly (hose with sensor).

Updated sensor can be serviced separately from hose, see ETKA under part number **07K 906 051 ***.

- Install sensor Service-kit Part Number: 07K 198 125.

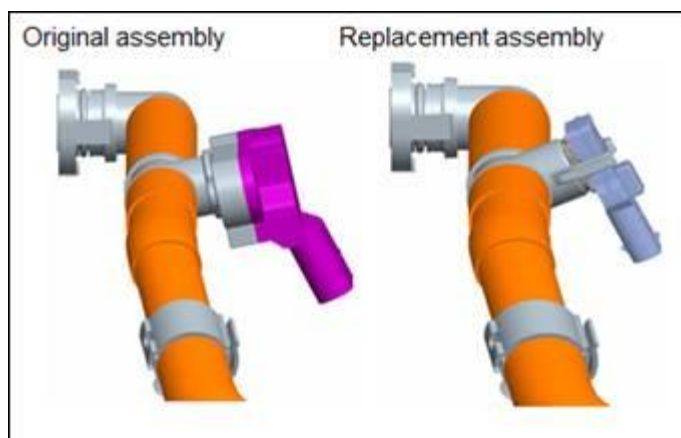
Service-kit uses a different sensor and connector.

An adapter harness is supplied with sensor Service-kit. It is to be connected between the vehicle harness and the new sensor.
