Technical Service Bulletin

94 Daytime running light (DRL) inoperative, DTC 02895 and/or 02897 is stored in the central electrics control module

94 19 06 2032184/8 April 30, 2019. Supersedes Technical Service Bulletin Group 94 number 16-80 dated September 7, 2016 for reasons listed below.

Model(s)	Year	VIN Range	Vehicle-Specific Equipment
Q5	2013-2017	All	LED Daytime Running Lights

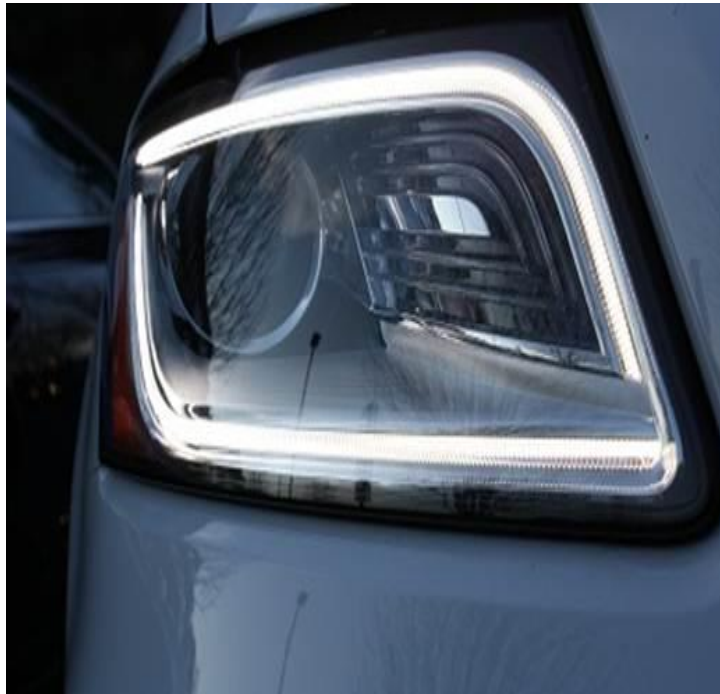
The MY2013+ Audi Q5 LED DRLs use light-emitting “pipes” or “guides” instead of multiple, individual LEDs. There are two light pipes per headlight. Each light pipe uses a single LED for illumination (Figure 1).

Figure 1. Upper and lower light pipes illuminated.

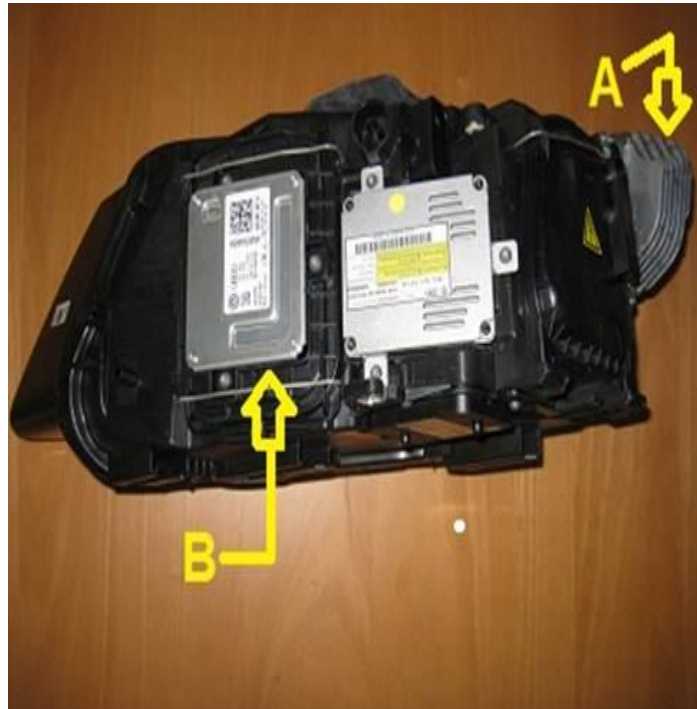
The LEDs with heatsinks are contained in a single module (Figure 2, A) mounted to the outer backside of each headlight.

Figure 2. The backside of the headlight with LED heat sink (A) and LED control module (B).

The LED unit with heat sink utilizes a gasket and is keyed into the headlight housing to maintain proper alignment of each LED and light pipe. The LED units (L176 and L177, left and right, respectively) are controlled via a control module (J860 and J861, left and right, respectively) located separately on the backside of the headlight (Figure 2). These LED units and LED control modules are electrically interchangeable from side to side, but the LED units are mechanically specific to each headlight side.

1. With the ignition off, remove the DRL control module (Figure 2, B). See repair manual for instructions.

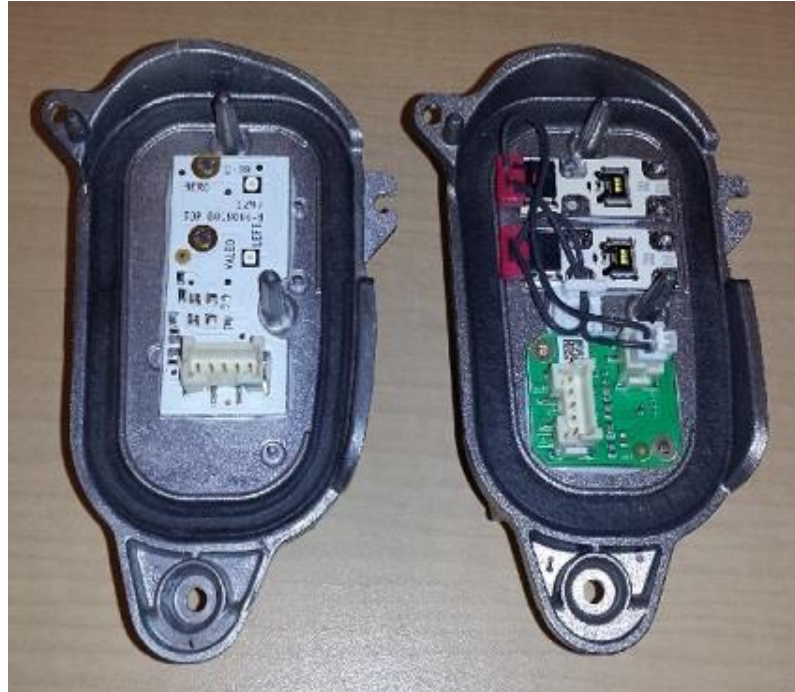
As of March 12th, 2013 production, the LED unit with heat sink has been updated (Figure 3). If a failure

occurs, these parts do *not* need to be replaced in pairs.

Figure 3. Current (left) and early (right) style LED DRL units.

The appearance of the replacement part for the LED DRL has changed, but functionality is the same. If an LED DRL needs to be replaced, they do not need to be replaced as a pair.

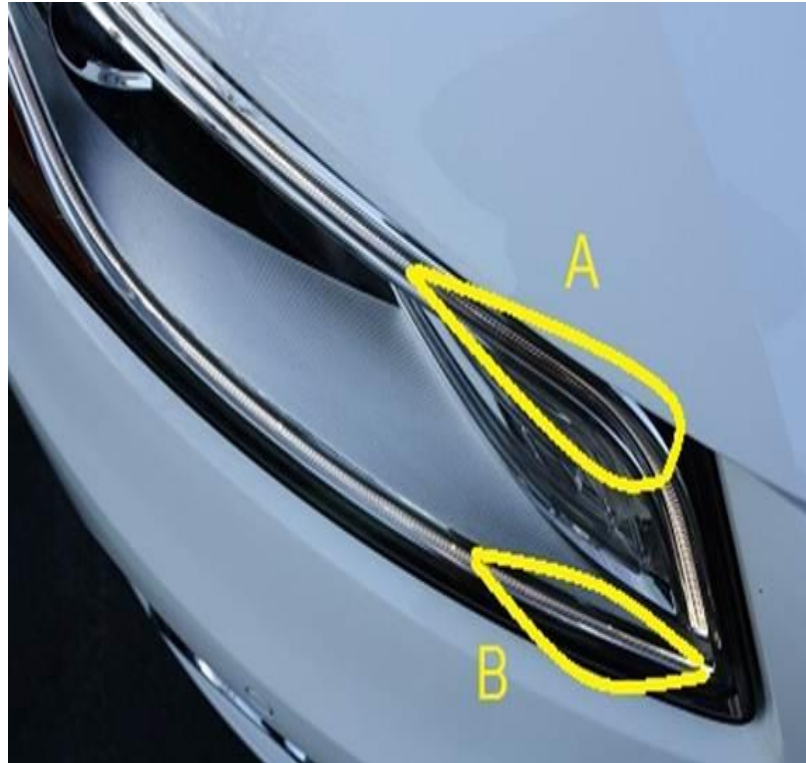
- A defect may be perceived for top-down viewing angle (Figure 4).

Figure 4. Upper light pipe perceived defect (A). Lower light pipe perceived defect (B).

Explain to the customer that the LED illumination appears differently to someone standing in front of the vehicle than it appears to oncoming traffic. The viewing angle of someone standing in front of the vehicle will give a visual effect of an LED DRL inoperative or partially-inoperative condition.

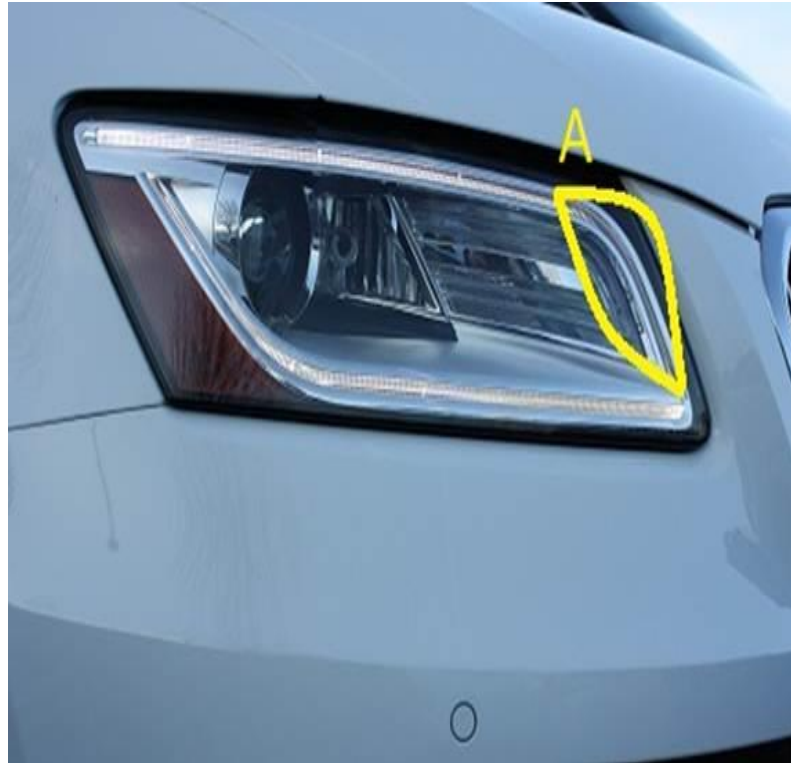
- A defect may be perceived for corner viewing angle (Figure 5).

Figure 5. Upper light pipe perceived defect (A).

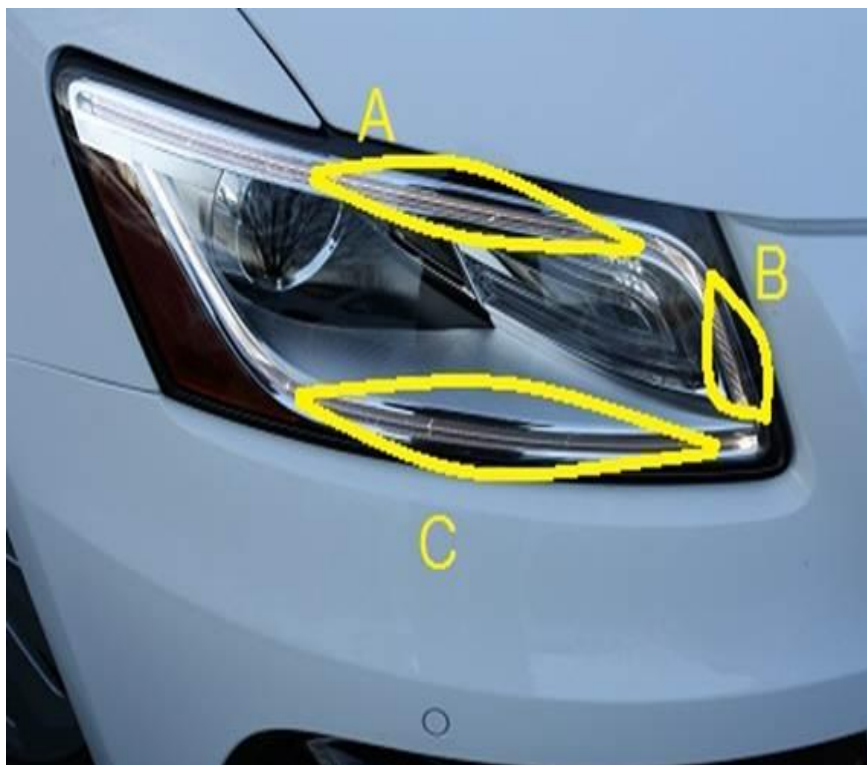
- A defect may be perceived for the acute corner viewing angle (Figure 6).

Figure 6. Upper light pipe perceived defect (A, B). Lower light pipe perceived defect (C).

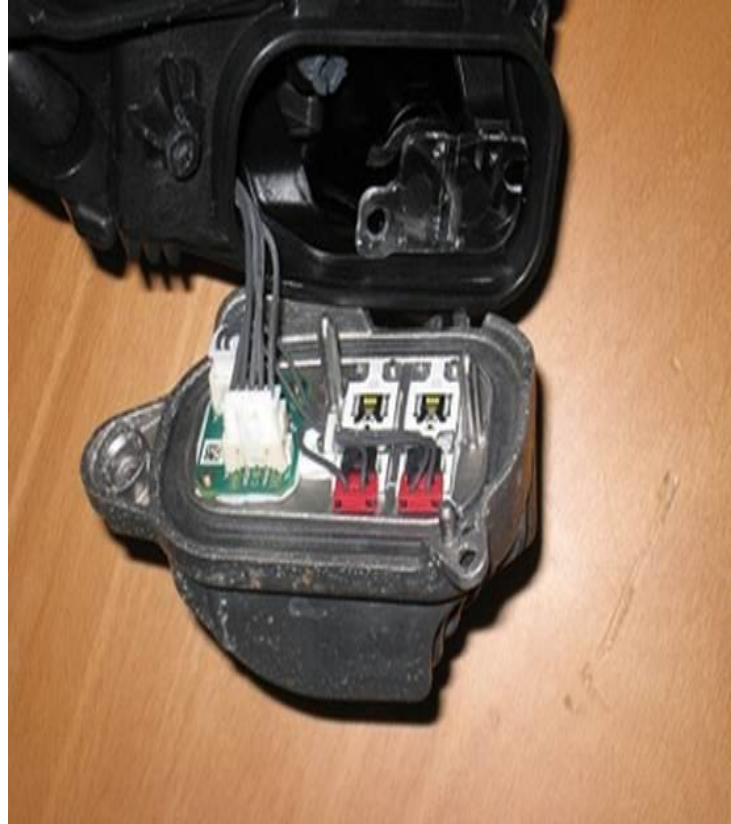
Figure 7: Dual surface mount LED unit exposed.

2. Check the connector at the module and secure if loose. If necessary, remove the connector and reinstall to ensure that the connector is engaged properly. The wiring harness guide of the terminal housing may impede connector engagement.
3. With ignition still off, remove the LED unit with heat sink from headlight housing (Figure 7). See repair manual for instructions. Inspect and secure all electrical connectors, if loose. Remove and secure the white connectors, even if they do not appear to be loose.

4. Turn ignition on to see if DRL is now operating to specifications.

Be extra careful with red surface mount connectors. In general, a repair kit is not available for any internal headlight connectors.
