## TECHNICAL SERVICE BULLETIN

### High Roof Bus/Passenger Wagon - Headliner Loose Or Unseated At The C And/Or C 1/2 Pillar(s)

**19-2108**  
17 April 2019

<b>Ford</b> 2015-2019 Transit
----------------------------------

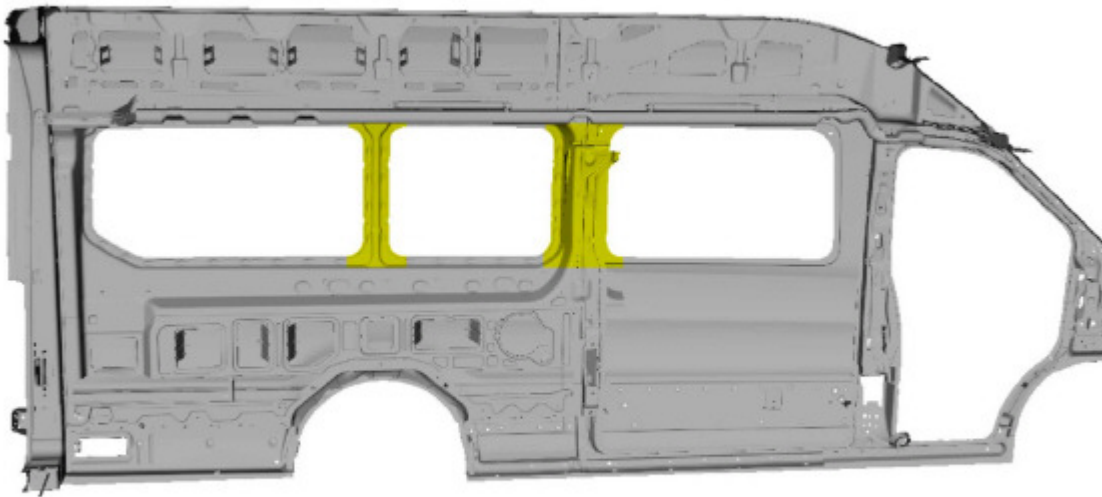
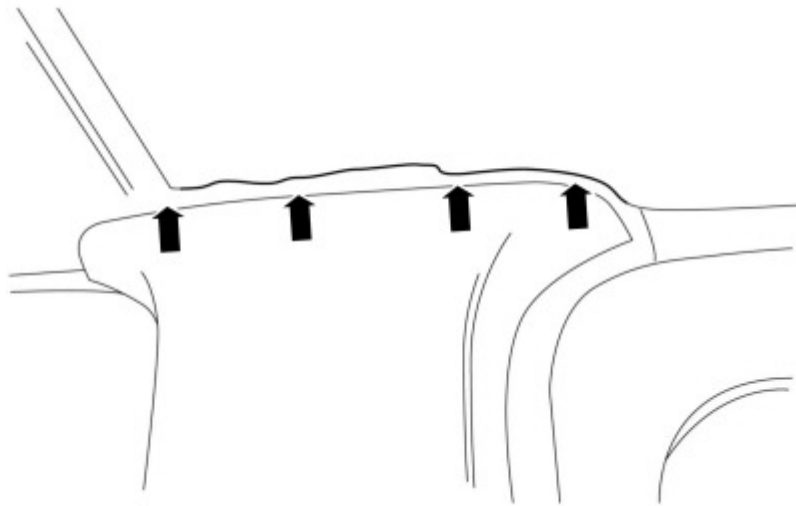
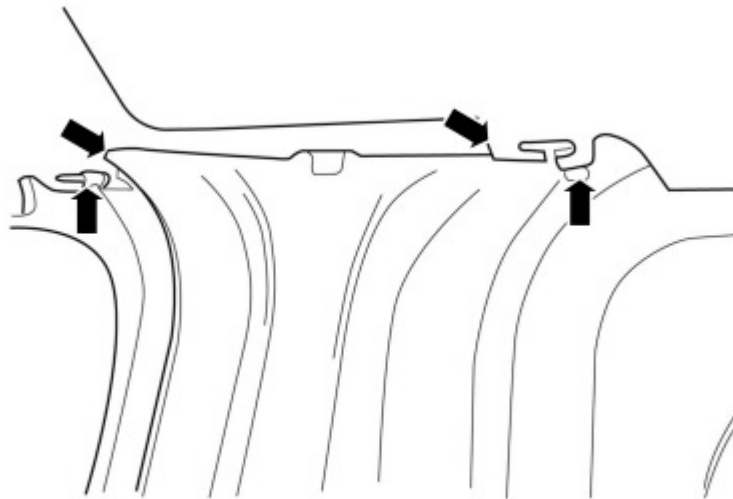
**Issue:** Some 2015-2019 Transit High-Roof Bus/Passenger Wagon vehicles may experience a loose or unseated headliner at the C and/or C 1/2 pillar(s) causing visible gaps. This may be due to a lack of retention capability of the headliner locator tabs to the pillar block pins. To correct the condition, install repair coupons to the headliner and replace the headliner A/C vent foam gaskets.

1. Does this vehicle have a high roof with a loose or unseated headliner causing a gap issue at the C and/or C 1/2 pillar(s), misalignment between headliner locator tab and pillar block pins? (Figures 1-3)
