**** TECHNICAL INFORMATION NOTICE ****

DATE: April 25, 2018
TO: Mitsubishi Motors US & Puerto Rico Dealer Service and Parts Managers
RE: CPX-930 Software Update
TIN NO. TIN-19-00-002

AFFECTED VEHICLES: All models and model years

CPX-930 Update with USB

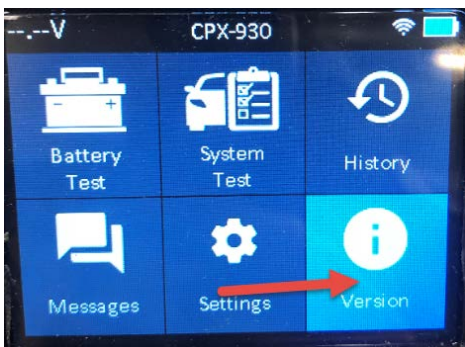
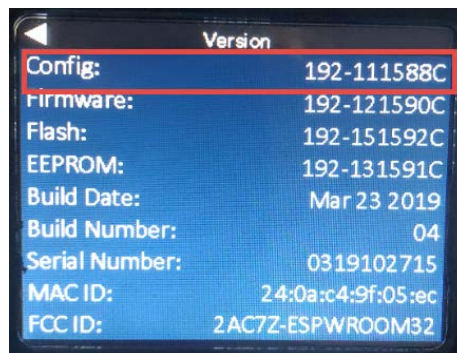
NOTE: Dealers currently at software configuration 192-111588C are at the current software configuration number and will not be sent this update package.

To check your software configuration number, from the main menu:

1. Select version
2. Check the "config" number

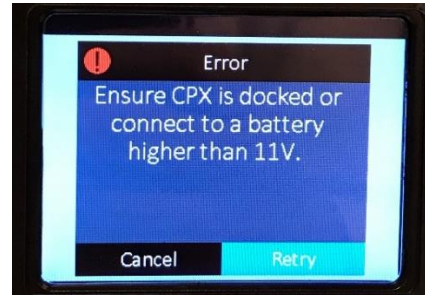
Error: *Ensure CPX is docked or connect to a battery higher than 11V.*

1. The CPX should be firmly seated into the docking station.
2. The CPX should not be removed from the docking station during the update.
3. Make sure the power supply is plugged into an appropriate outlet and the barrel connector is firmly inserted into the docking station.

- To check the power supply, use a multi-meter and test for 12V on the power supply barrel connector. If 12V is not present, a new power supply is required for the docking station.

4. Inspect the charging pins in the base of the docking station and the charging connections on the bottom of the CPX. Pins should depress easily and charging connections should be clean and free of debris.

- Using a multi-meter, test for 12V on the charging pins. If 12V is not present a new docking station is required.
5. If power supply and docking station are working properly and this error continues, call Technical Support (information below).

6. If connected to a battery, check battery voltage and ensure it is greater than 11V.
