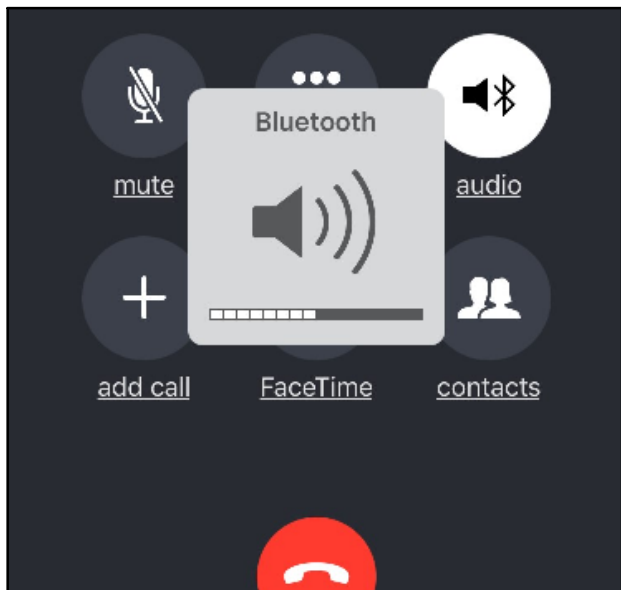
While driving at highway speeds and while on a Bluetooth connected phone call, the driver may have a difficult time hearing an incoming caller even if the volume level on the head unit is set to maximum.

2) On initial phone pairing of smartphone devices with MMNA audio devices, the phone Bluetooth volume setting will change. The Bluetooth audio and Bluetooth call audio volume settings will be automatically adjusted to a lower volume setting by default.

To access and increase the Bluetooth volume on Bluetooth audio and Bluetooth calls, follow the steps below.

- Place vehicle in park and turn ignition switch on
- Pair the device
- Select head unit audio source "Bluetooth Audio"
- Increase volume on smartphone when music is playing while connected via Bluetooth. Music volume will increase and the operator should hear a noticeable volume change.

- Place vehicle in park and turn ignition switch on
- Pair the device
- Select phone on audio head unit and place a call
- While on a call begin increasing the volume on smartphone device (connected via Bluetooth). Call volume will increase and the operator should hear a noticeable volume change.
