# Technical Service Bulletin

SUBJECT:		No: <b>TSB-19-42A-003</b>	
<b>TORQUE UPDATES TO LIFTGATE REMOVAL &amp; INSTALLATION PROCEDURE - SERVICE MANUAL REVISION</b>		DATE: <b>April 2019</b>	
		MODEL: <b>2011-17 Outlander Sport/RVR</b>	
<b>CIRCULATE TO:</b>	<input type="checkbox"/> GENERAL MANAGER	<input checked="" type="checkbox"/> PARTS MANAGER	<input checked="" type="checkbox"/> TECHNICIAN
<input checked="" type="checkbox"/> SERVICE ADVISOR	<input checked="" type="checkbox"/> SERVICE MANAGER	<input checked="" type="checkbox"/> WARRANTY PROCESSOR	<input type="checkbox"/> SALES MANAGER

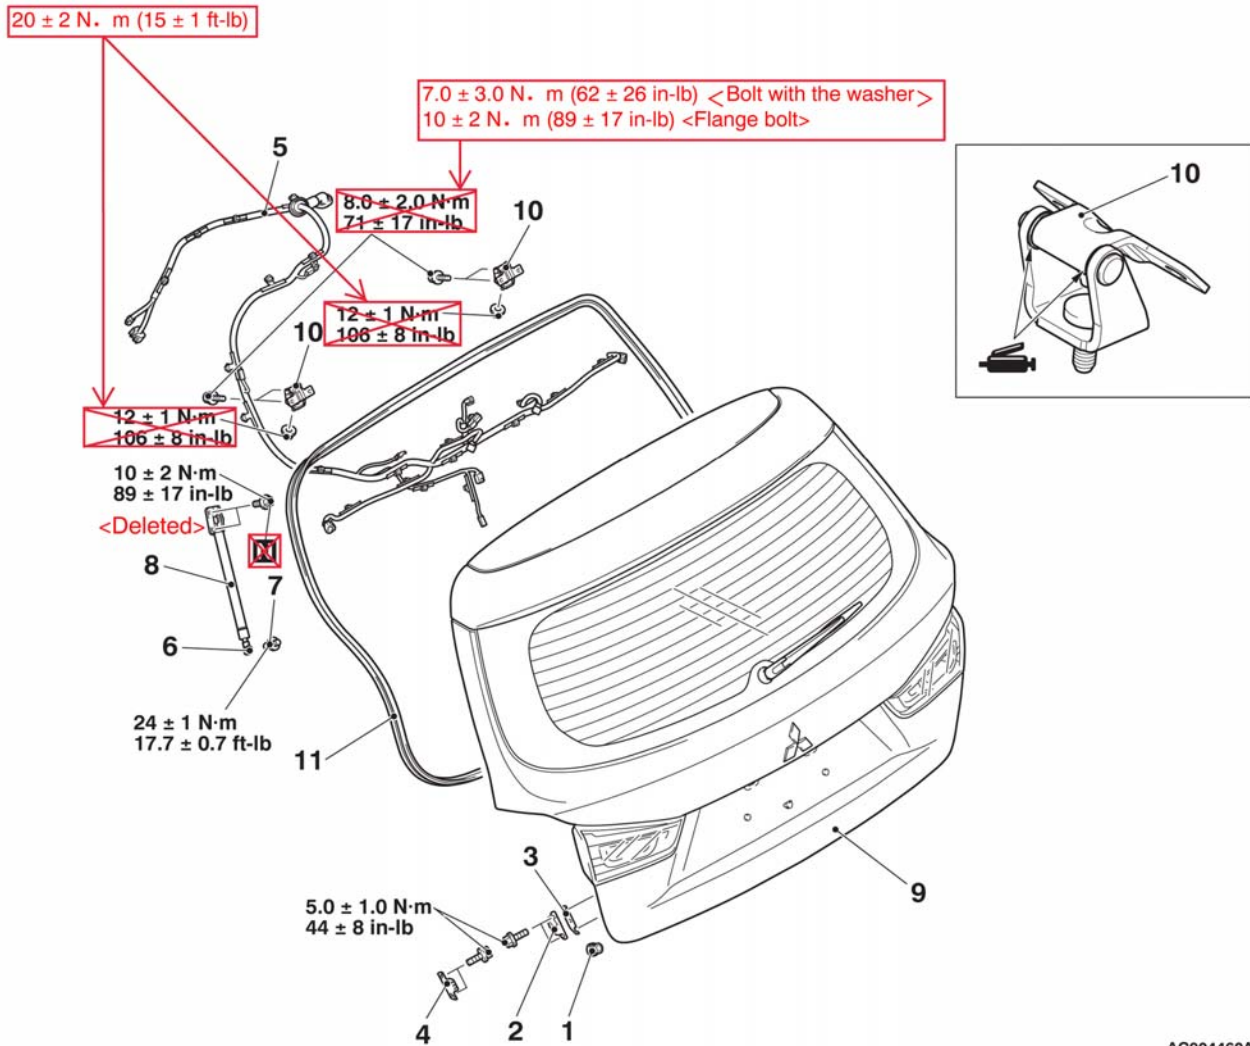
This TSB updates the Body section of the affected Service Manual, to correct the tightening torque for the liftgate removal and installation procedure, and to correct a non-reusable part indicator.

Please make the indicated changes to the 2011 - 2017 Outlander Sport Service Manual, Group 42-Body -> Liftgate -> Removal and Installation.
