Technical Service Bulletin

SUBJECT:			No:	TSB-19-34-003
UPDATE TO SHOCK ABSORBER ASSEMBLY			DATE:	April 2019
INSTALLATION - SMR			MODEL:	See below
CIRCULATE TO:	[] GENERAL MANAGER	[X] PARTS MANAGER		[X] TECHNICIAN
[X] SERVICE ADVISOR	[X] SERVICE MANAGER	[] WARRANTY PROCESSOR		[] SALES MANAGER

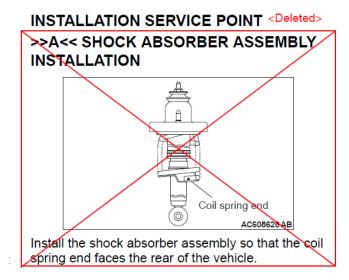
The installation direction of the coil spring end is not important when installing the shock absorber assembly (LH and RH).

Please make the indicated changes to the Service Manuals listed below, Group 34-Rear Suspension -> Shock Absorber Assembly -> Removal and Installation -> Installation Service Point.
