NUMBER: 08-033-15 REV. B

Flash: RE2 RE3 RE4 RE6 RE7 RB4 RB5 RB6 RB4 Radio Enhancements

This bulletin involves updating the radio control head software and navigation if equipped.

2013-2014	(LD)	Dodge Charger
2013-2014	(LX)	Chrysler 300
2013-2015	(JC)	Dodge Journey

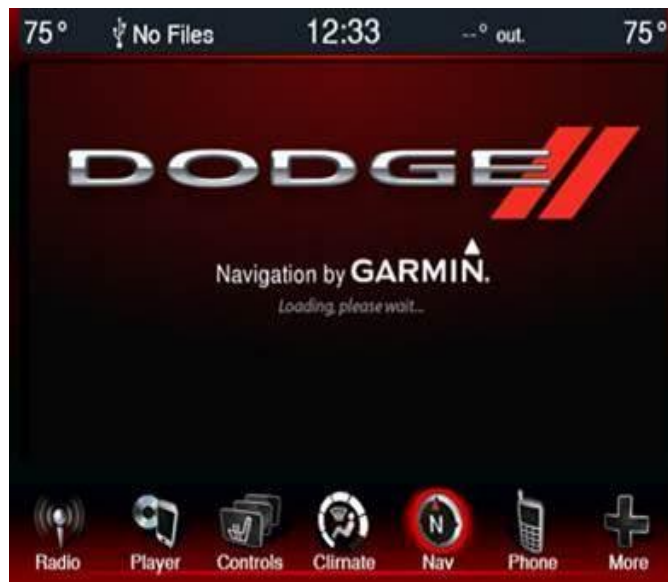
Fig. 1 System Loading Screen

3. Press the navigation screen button and attempt to access the navigation main menu system.
4. Is the radio stuck on the “Loading Please Wait” screen? See ([Fig. 1](#)).
 - a. Yes >>> The radio will have to be replaced. Replace the radio using current electronic exchange center stock following normal warranty repair procedures. Refer to published service information in Tech Connect Section 08 - Electrical/8E - Electronic Control Modules/MODULE, Telematics Gateway/Removal. No further action is required, the bulletin is now complete. The replacement radio will contain the latest software update.
 - b. No >>> Proceed to [Step #5](#) and perform the software update.
