# SERVICE BULLETIN

Classification: EL19-008	Reference: NTB19-031	Date: April 9, 2019
-----------------------------	-------------------------	------------------------

## BEEPING NOISE WHILE TRAVELING THROUGH OPEN AREA

**APPLIED VEHICLES:** 2017 - 2018 Rogue (T32)  
2017 - 2018 Rogue Hybrid (T32)

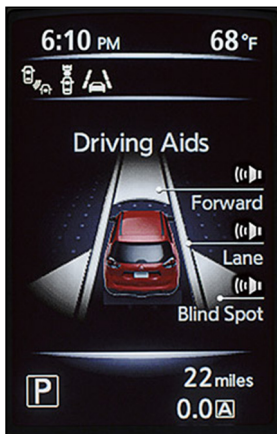
Customer reports continuous beeping noise and/or the **Driving Aids** screen shown in Figure 1 flashes, especially when driving in open areas similar to Figure 2.

Refer to **TABLE A** on page 8 to confirm if ICC/ADAS 2 control unit reprogramming is needed.
