Title	Mack Chassis - Equipped With A Cummins 9 Liter Engine - Serpentine Belt Excessively Worn Or Damaged; Fan Belt Shredding Or Fraying Repeatedly
-------	--

Mack Model	LR , MRU - TerraPro , TE - TerraPro , AN - Anthem , CHU - Pinnacle, Axle back , C XU - Pinnacle, Axle front , GR - Granite , GU - Granite , PI - Pinnacle
-------------------	---

Engine family	CU9 CNG , CU9
---------------	---------------

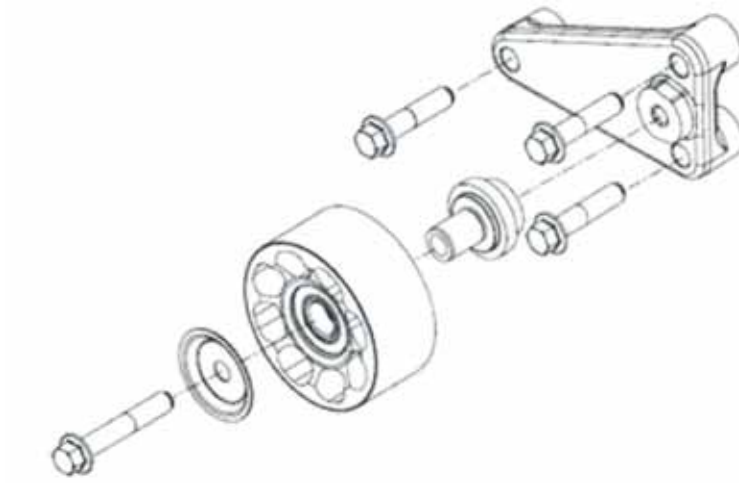
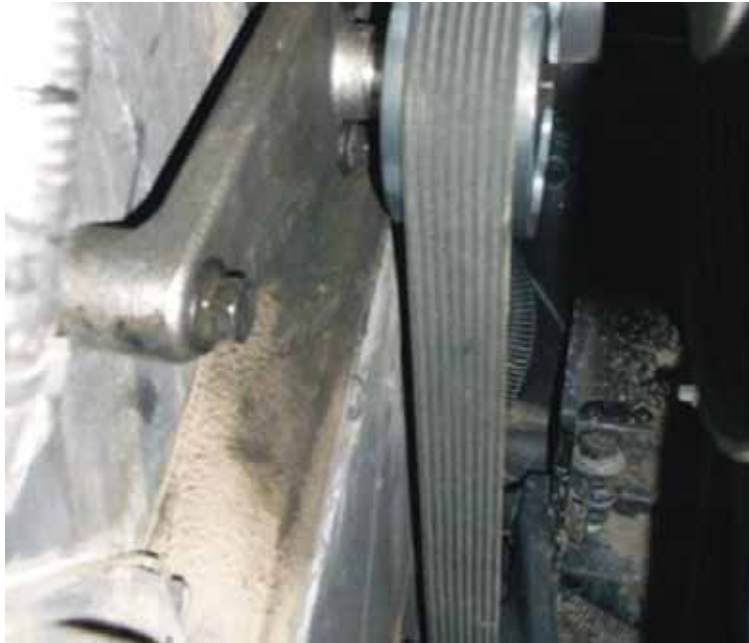
Cause	Cummins has determined that vehicles equipped with their 9 liter engine may experience belt slap due to a long span between the fan clutch pulley and the crankshaft pulley. This may lead to the belt shredding or fraying.
-------	--

1. Replace the belt tensioner arm.

Note: Cummins also offers an additional, optional idler pulley kit to further minimize belt fatigue and noise. It is recommended that this kit be installed on vehicles used in time-critical applications. See part number below.

- Idler Kit, Cummins Part Number 5335096
- Belt - Refer to IMPACT
