Title Diagnostic Trouble Codes (DTC) P20EE And P103C, Diagnostic Procedure; **REPLACE S GUIDED DIAGNOSTICS IN PREMIUM TECH TOOL ( PTT ) - US17+OBD16 And Newer Chassis ONLY**

**Mack Model** LR , MRU - TerraPro , TE - TerraPro , AN - Anthem , CHU - Pinnacle, Axle back , C XU - Pinnacle, Axle front , GR - Granite , GU - Granite , PI - Pinnacle

**Volvo Model** VNL , VNM , VNR , VAH , VHD

Engine family 11L Engine , 13L Engine , MP7 , MP8

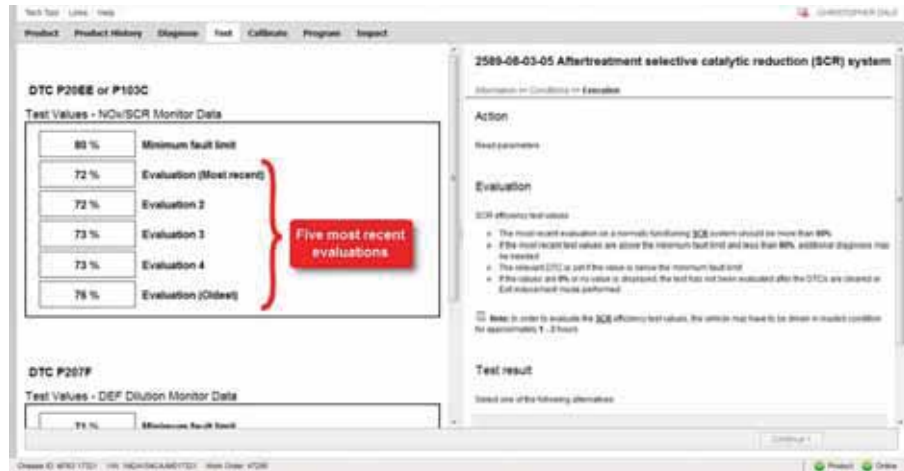
- The last five efficiency evaluations are displayed as shown in the screenshot above.
  - If all five tests are below the fault limit, SCR conversion has been poor for an extended amount of time.
  - If only one or two are below the fault limit, conversion is only intermittently poor.
    - Information on driving conditions when the poor conversion is occurring may provide insight into the cause of the codes.

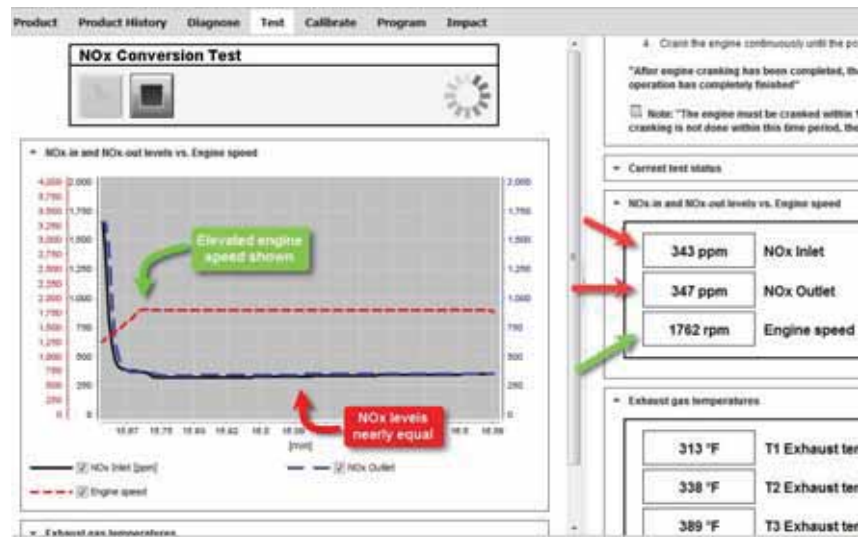
- **Note:** This test checks the function of both NOx sensors. It does not evaluate SCR efficiency.
- While running NOx conversion test, if any new NOx sensor codes are logged (Egs: P220E-93, P220F-93), make sure to troubleshoot those codes.
- Inlet and Outlet NOx Sensor values should be close to each other at high engine speed (last portion of the test) as shown below.

If during the test difference between NOx sensors are greater than 10%, we recommend replacing sensor reading higher value and re-do the test.

The likelihood that both sensors require replacement at once is low. Replacement of both sensors at once should not be considered immediately unless affected by an upstream failure.
