EL19-010

ITB19-009

## INTELLIGENT KEY DOES NOT WORK AFTER BATTERY REPLACEMENT

**APPLIED VEHICLES:** 2019 QX50 (J55)                      2019 Q50 (V37)  
2019 QX60 (L50)                                      2019 Q60 (V37)  
2019 QX60 Hybrid (L50H)

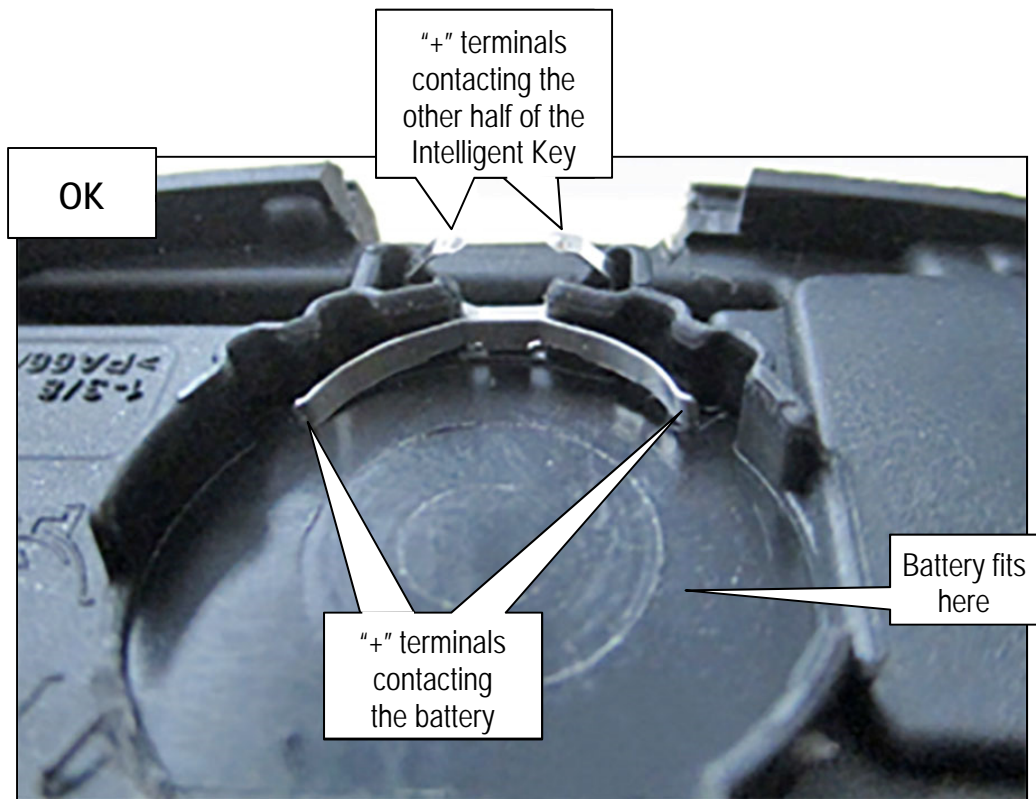
Figure 1

If the battery side of the Intelligent Key is held by pinching down on the terminals while removing the battery, it is possible to bend the terminals down far enough that they will not touch the contacts on the other half of the Intelligent Key.

If the terminals are found to be bent down, pry them back up so that they will come in contact with the other half of the Intelligent Key's contacts.
