Title *Expired - Refer To P20EE Solutions - NOx Conversion Test (Test -- 2549-08-03-03) Interpretation*

**Mack Model** Cabover , LEU , LR , MRU - TerraPro , Conventional , CHU - Pinnacle, Axle back , CXU - Pinnacle, Axle front , GU - Granite , TD - Titan

**Volvo Model** Conventional , VNL , VNM , VNX , VAH , VHD

Engine family Volvo , 11L Engine , 13L Engine , 16L Engine , Mack , MP7 , MP8 , MP10

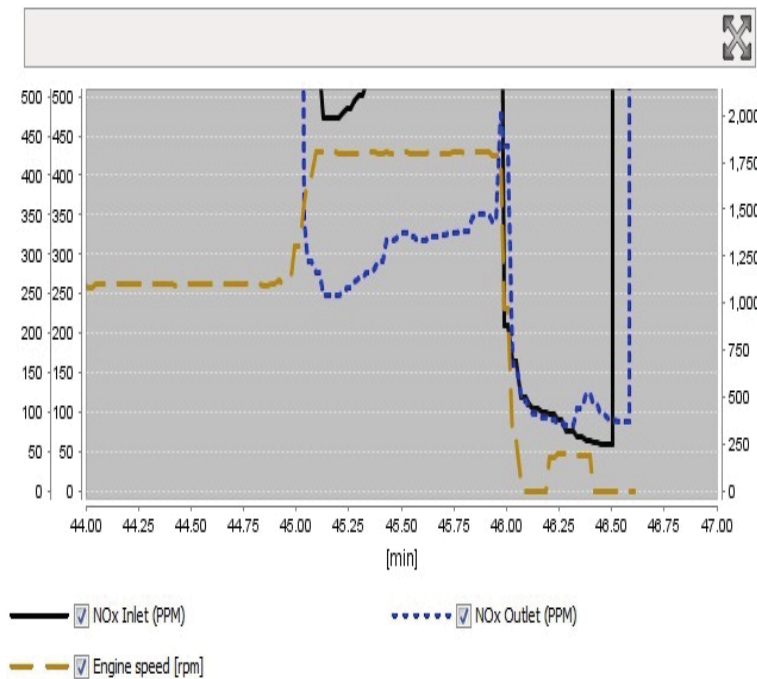
## NOx-in and NOx-out levels vs. Engine speed

Egs: **Truck had MIL ON due to P2201 fault** (NOx1 sensor rationality fault). NOx conversion test showed the following results (Typical Good NOx1 value before shutdown is around 300ppm).

**For the case below, we should be replacing NOx1 sensor, not NOx2 sensor.**

The test was not executed successfully. Please repeat the test again.

Inlet NOx sensor zero level

Outlet NOx sensor zero level

Observe the values in the graph for a few minutes. NOx sensors values do not deviate from 0 PPM.

Sensor replacement is only needed if the NOx sensor value is higher than 10 PPM prior to engine speed r
