Title Diagnostic Trouble Code (DTC) P009B-13 Fuel Pressure Relief Control – Circuit Open;
Possible Derate - **US17+OBD16 And US17+OBD18 Emissions, Model Years 2018
And 2019**

Mack Models

Volvo Model VNL , VNR , VNX , VAH , VHD

Engine family 11L Engine , 13L Engine , MP7 , MP8

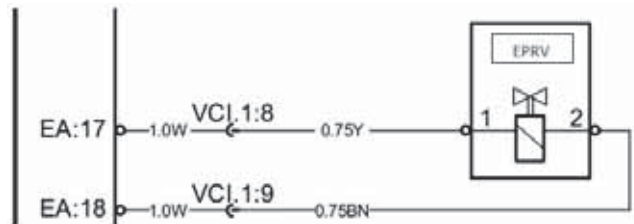
1. Visually inspect wiring, connectors, pins, terminals, etc. from Engine Control Module (EMS) Connector EA (Pins 17 & 18) through the VCI Connector (Pins 8 & 9), to the connector at the ERPV.

2. Using a Digital Volt Ohm Meter (DVOM), measure resistance between the pins below. **Expected resistance is <1.0 ohm.**

- Between EA:17 and VCI 1:8
- Between EA:18 and VCI 1:9

- **If an open circuit or high resistance is found:** Make necessary repairs.
- **If no issues are identified:** Replace the ERPV and the front internal engine harness.
- **For all repairs:** Apply Permatex Dielectric Grease part no. 81150 or 22058 to the pin and socket terminals of the ERPV and harness connector. The grease may be sourced locally.
