SI B13 02 19
Fuel Systems

SERVICE ACTION: CHECK THE TANK VENT VALVE LINE

G01 (X3 xDrive30i, X3 M40i)			
-----------------------------	--	--	--

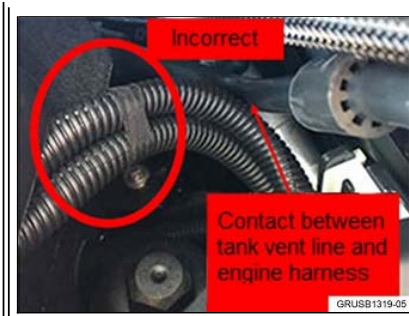
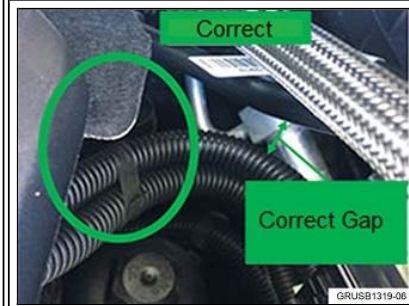
Visually inspect engine wiring harness and tank vent valve line.

If the clearance between the tank vent valve and engine harness is incorrect and the tank vent valve line is damaged, it must be replaced.

Installation of a spacer is not needed in this case as the

replacement tank vent valve line will have the spacer installed.

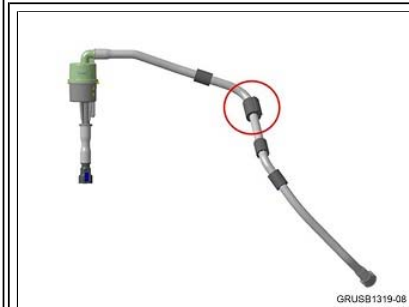
If the clearance between the tank vent valve and engine harness is correct and the tank vent valve line **is not** damaged, install an additional spacer.

Install the new spacer after the bend between the first and second existing spacer on the tank vent valve (TEV).

The installation location of the new spacer is shown circled in red.
