# Technical Service Bulletin

## 91 MIB2 High: rearview camera/overhead view camera does not turn on

91 19 59 2055026/1 May 15, 2019.

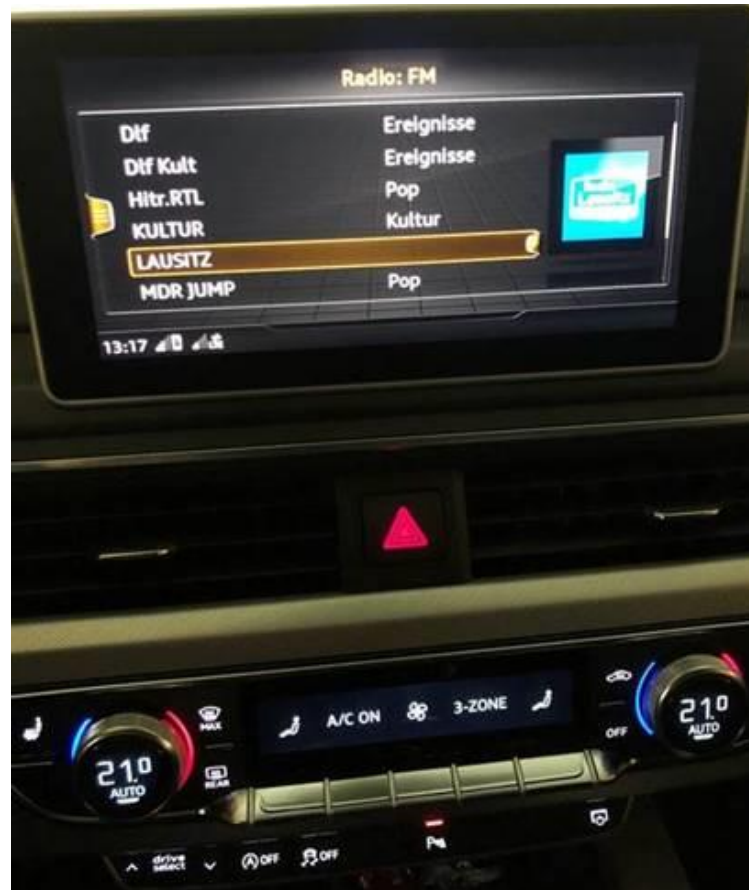
- The rearview/overhead view camera and the optical parking aid are sporadically not switched on when moving into reverse. The previously adjusted menu (radio, navigation, etc.) stays the same (Figure 1).
- The parking aid button in the center console lights up and an acoustic obstacle warning is given.

Figure 1. Previously adjusted menu stays the same.

The MIB2 High software needs to be updated.

Update the MIB2 High infotainment system using either Method 1 or Method 2 according to TSB 2047576: *91 MIB2 High Software Update Instructions (PR Code 7UG)* and use SVM code indicated below:
