# Service Bulletin

Bulletin No.: 19-NA-069

**Subject:** Paint Chip(s) or Wear Mark(s) on Underside Hood Inner Panel, Near Windshield

Brand:	Model:	Model Year:		VIN:		Engine:	Transmission:
		from	to	from	to		
Cadillac	XTS	2018	2019			All	All

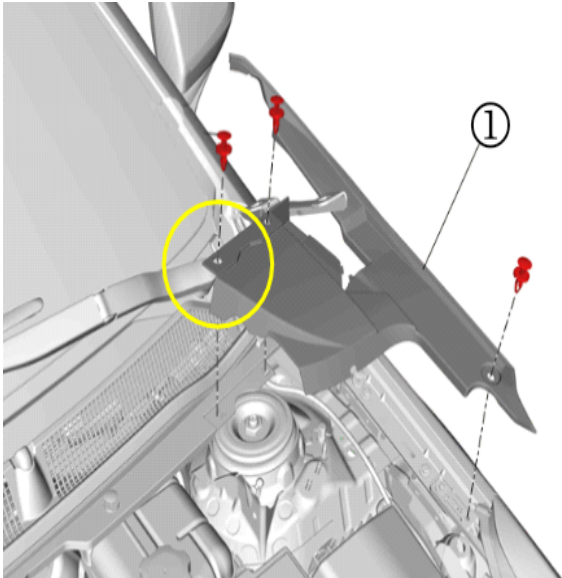
<b>Involved Region or Country</b>	North America and N.A. Export Regions
<b>Condition</b>	Some customers may comment on seeing a paint chip or wear mark on the underside hood inner panel, near the windshield. This could occur on either, or both, the driver and passenger side.
<b>Cause</b>

<p style="text-align: right; font-size: small;">5299013</p> <p><b>Note:</b> The inboard, rearward corner (shown circled in the illustration above) is the most common hood damage area.</p> <p>The cause of the condition may be because of interference between the hood inner panel and the front compartment sight shield (1), near the windshield. The marring, or chipping, results from the contact and vibration while driving.</p>
<b>Correction</b>	Complete partial paint repair to the damaged area(s) and add mylar tape to both sides, following the steps in the Service Procedure below.

1. Clean the affected area(s) with soap and water.
2. Solvent wash the area(s) and wipe dry.
3. Scuff and sand the area(s) smooth.
4. Epoxy prime the repair area(s)
5. Refinish top coat.
