**SERVICE PROGRAM BULLETIN**

**APPLICABILITY:** 2017 MY Legacy  
2017 MY Outback

**NUMBER:** WUD-89

**SUBJECT:** Combination Meter Reprogramming Service Program

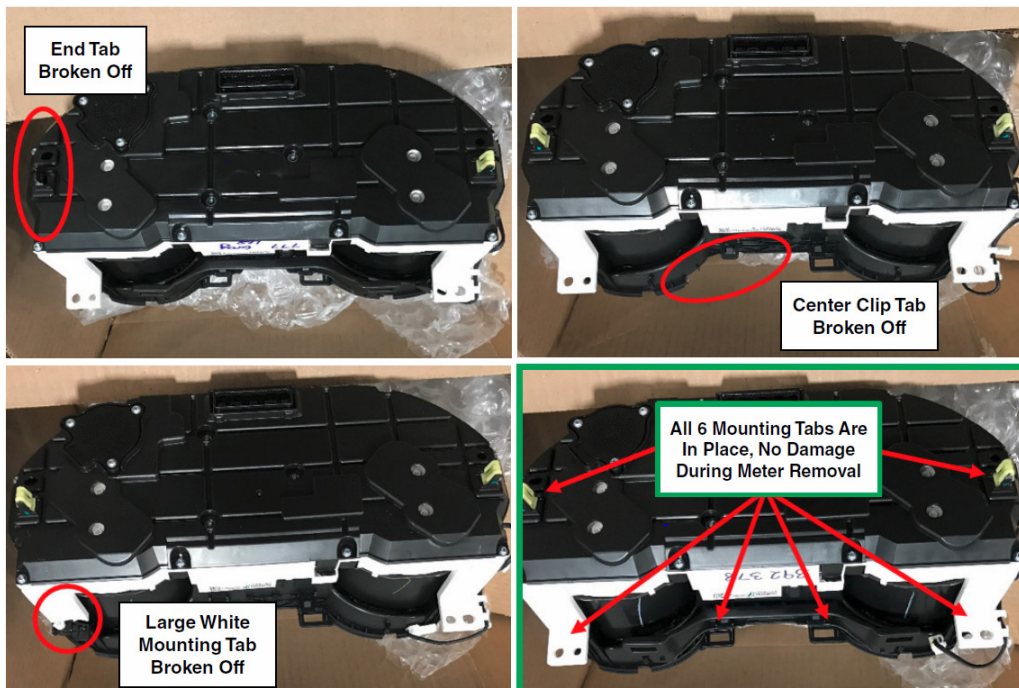
Before proceeding to **Step 6** below, it must be stressed to **TAKE YOUR TIME** when removing and reinstalling the combination meter. The photos below illustrate what can happen to the meter assembly when not performing these steps **CAREFULLY**. These 3 examples show damage caused by outside influence which is not a matter for warranty.

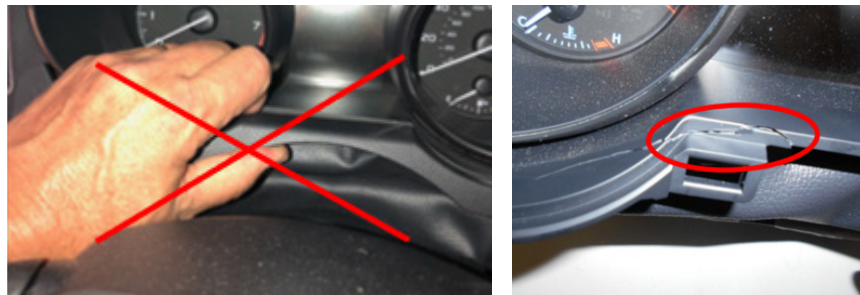
**Step 6: NOTE:** Previously, the removal procedure showed releasing the top claws on each end, grasping the bezel with the thumb and forefinger and pulling straight back to release the 2 center retaining clips. Use the photos below for reference when **CAREFULLY** removing the combination meter lower trim bezel. Reports of damaged meter housings as shown in the example photo below, right have necessitated revisions to this step since the release of the WTW-82 campaign.
