Preliminary Information

PIP5569A Module Damage From Incorrect AFIT Usage On Vehicles With Direct Fuel Injection

Product Investigation Review Required

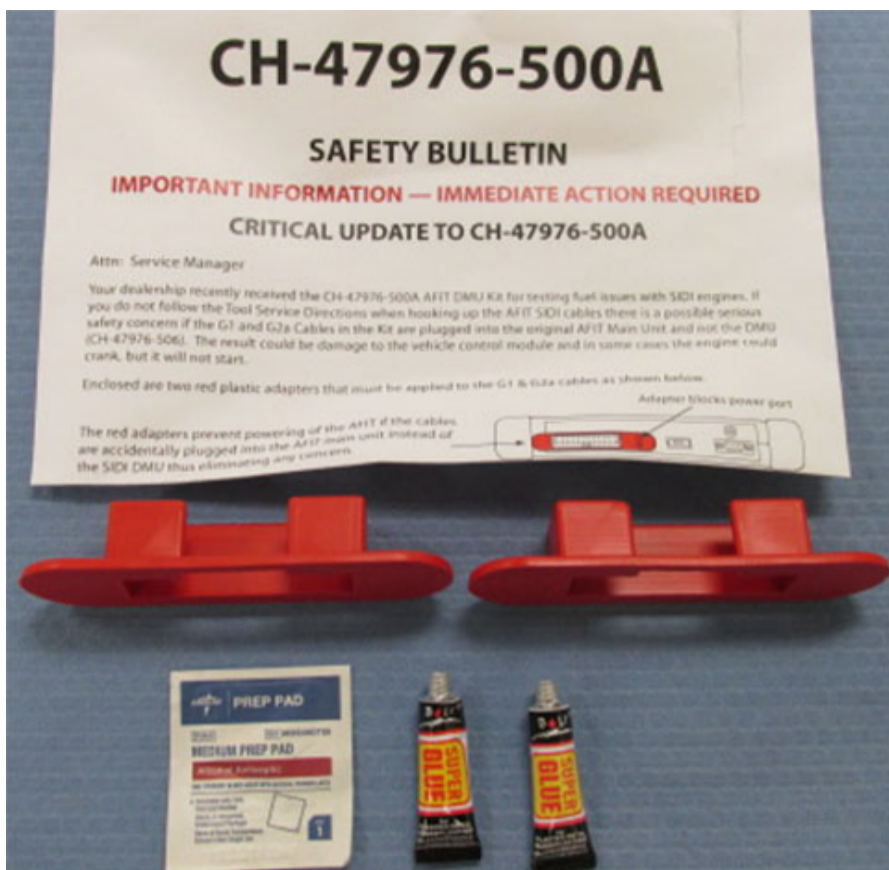
The Kit provided to dealers to install on SIDI cables:

GM dealers were sent an update kit to prevent the MCU's power supply from being connected if SIDI testing cables were connected directly to the MCU.

This kit contains guards/adapters that are permanently attached to the end of the SIDI testing cables with adhesive (see below).

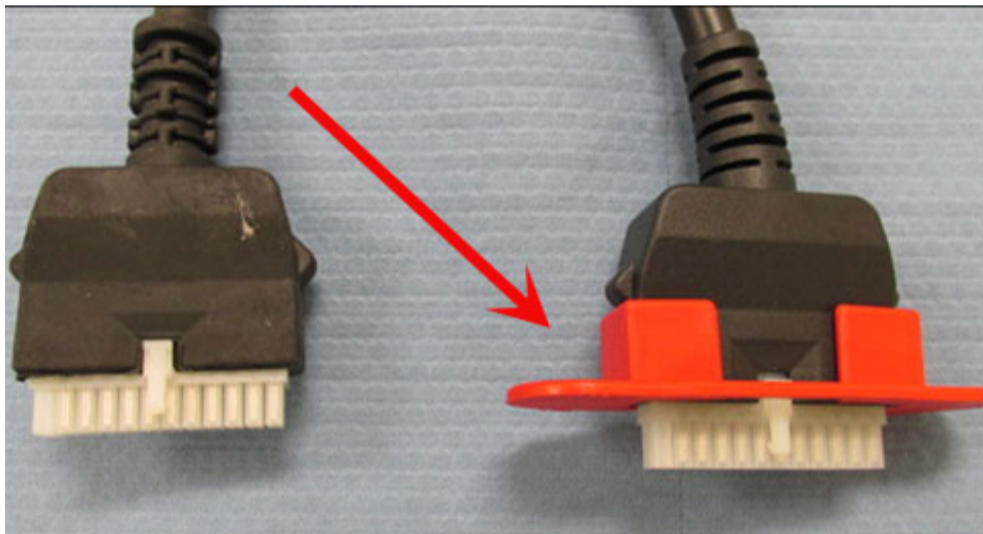
The adapter/guard properly installed on the end of the SIDI cable:

Verify the guards/adapters are installed properly on the cables and have not been modified in anyway, if the

guards are not present, install to prevent future damage.

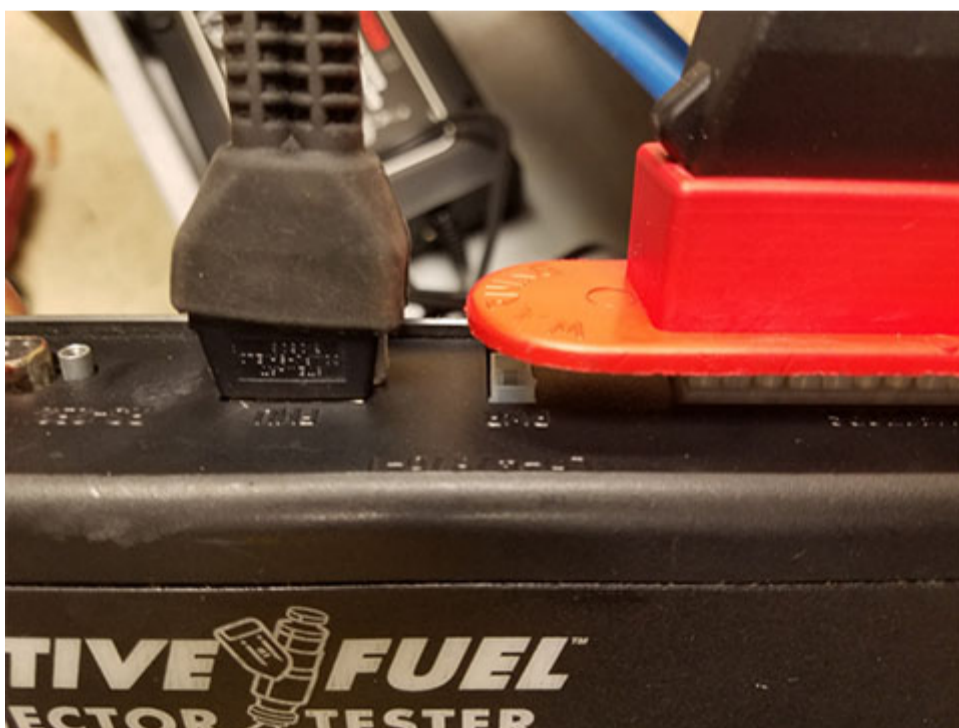
With adapter/guard properly installed it will cover the power plug port on the MCU if the SIDI cable is mistakenly plugged into the MCU:
