Preliminary Information

PIP5331H Ticking, Tap, or Rattle Noise From Engine

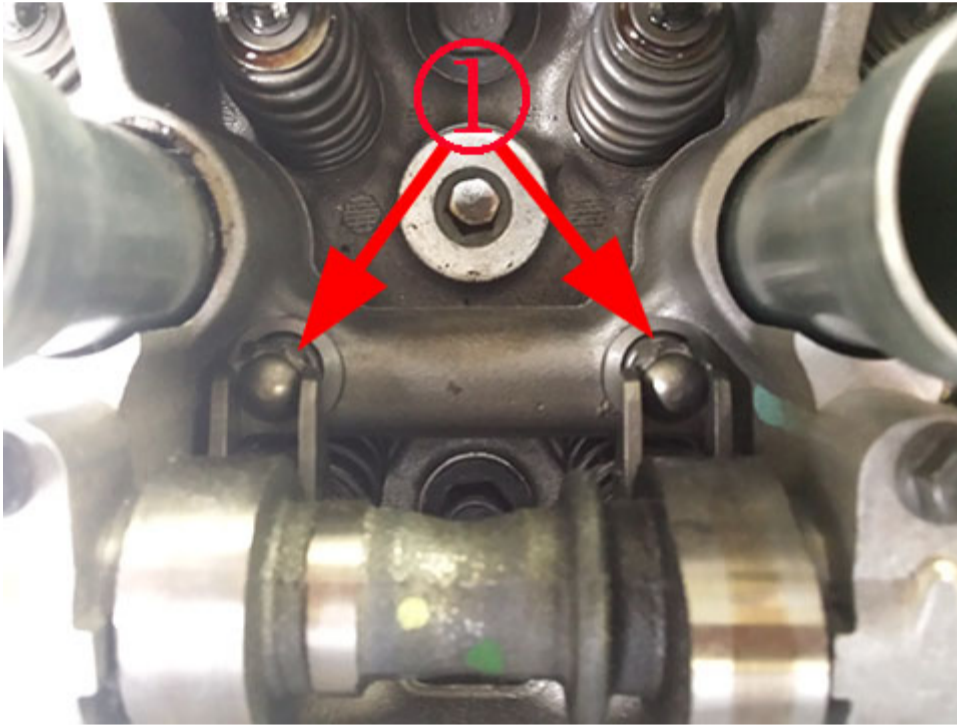
SEE PICTURE

a) Push down on the rocker end at the SHLA to test for soft or spongy. (right side exhaust are most common but could be any)

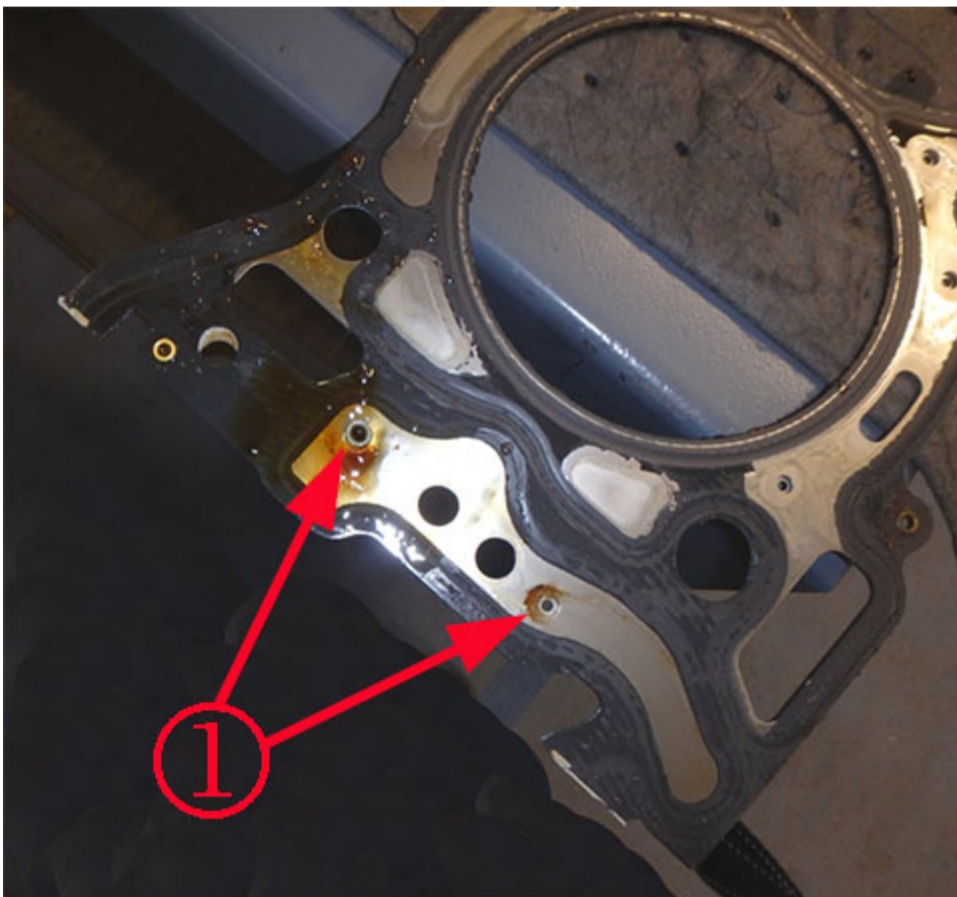
b) If soft or spongy SHLAS are found, carefully remove the affected head and inspect the oil passage below the head gasket for debris.

- c) If debris is found, inspect the camshaft caps for wear or discoloration due to lack of oil.
- d) If wear or discoloration is found then replace the cylinder head assembly with camshafts.
- e) If there is no wear or discoloration, clean the oil passages and replace the head gasket.
- f) Change the oil and filter.
- g) Reevaluate the noise concern.
