Revision: C Step 7, text modified to put more emphasis on the 1800 rpm 05/22/2019
 & time=15.33 minutes requirements.

P20EE (diagnostic troubleshooting code) SOLUTION - NOX CONVERSION EFFICIENCY

Prevost vehicles B13R (9700 us/can)

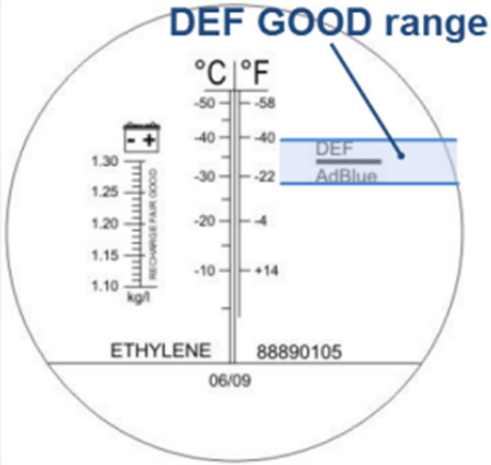
</div> <p>Apply a drop of DEF on the viewer of the refractometer. If the level is above the word "DEF" or below the word "AdBlue" the DEF is contaminated. If no level is shown, it may indicate chemical residue, such as pure water or diesel fuel.</p> <p style="text-align: center;"> ➔ Is the DEF of proper concentration? YES <input type="checkbox"/> NO <input type="checkbox"/> </p>	
---	---	--

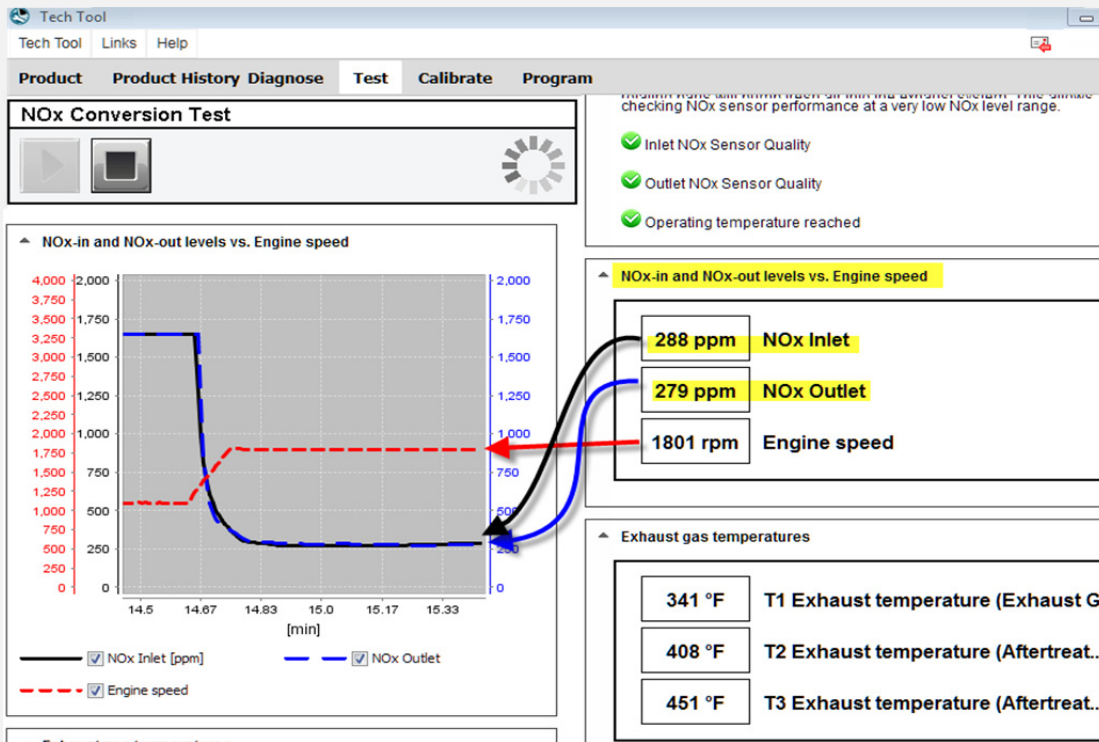
Most important part of this test is to check and compare the inlet and outlet NOx sensor ppm levels at high speed (near 1800 rpm), just before shutdown. **Take a screen capture at 1800 rpm at time 15.33 minutes**

If both NOx sensor ppm levels are **close to each other** at that point as shown on the image below, then both NOx sensors are good.

If ppm levels difference is **greater than 10%**, then the sensor reading higher should be considered as defective.

$$ppm\ levels\ difference\ (\%) = \frac{highest\ value - lowest\ value}{lowest\ value} \times 100$$

$$Ex.: ppm\ levels\ difference\ (\%) = \frac{(288-279)}{279} \times 100 = 3.2\ (\%)$$

Replace the defective sensor¹ if applicable and then perform a new NOx sensor test once again to make sure that the replacement sensor is good.

¹ Change only one sensor, since both will eventually be replaced with the new SCR converter
