### PIP5495J Check Engine Light On With P0299 Or P0234

#### Models

Involved Region or Country:	North America
Condition:	All turbochargers that are returned to the Warranty Parts Center (WPC) are inspected by Engineering for root cause failure.  The purpose of this information is to reduce the number of no trouble found (NTF) turbochargers being returned to the WPC by informing the Service Department personnel of what inspections and/or diagnosis to perform, prior to replacing and returning a turbocharger to the WPC. Read the entire bulletin prior to beginning any work.
Cause:	Misdiagnosis Leading to Returned Turbochargers with NTF

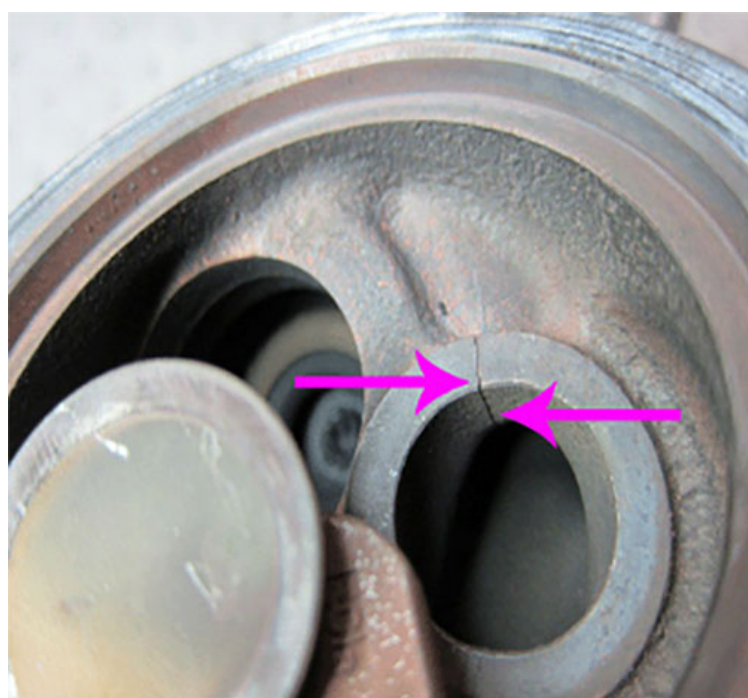
Crack(s) at the wastegate valve port (this is normal and does not affect performance)

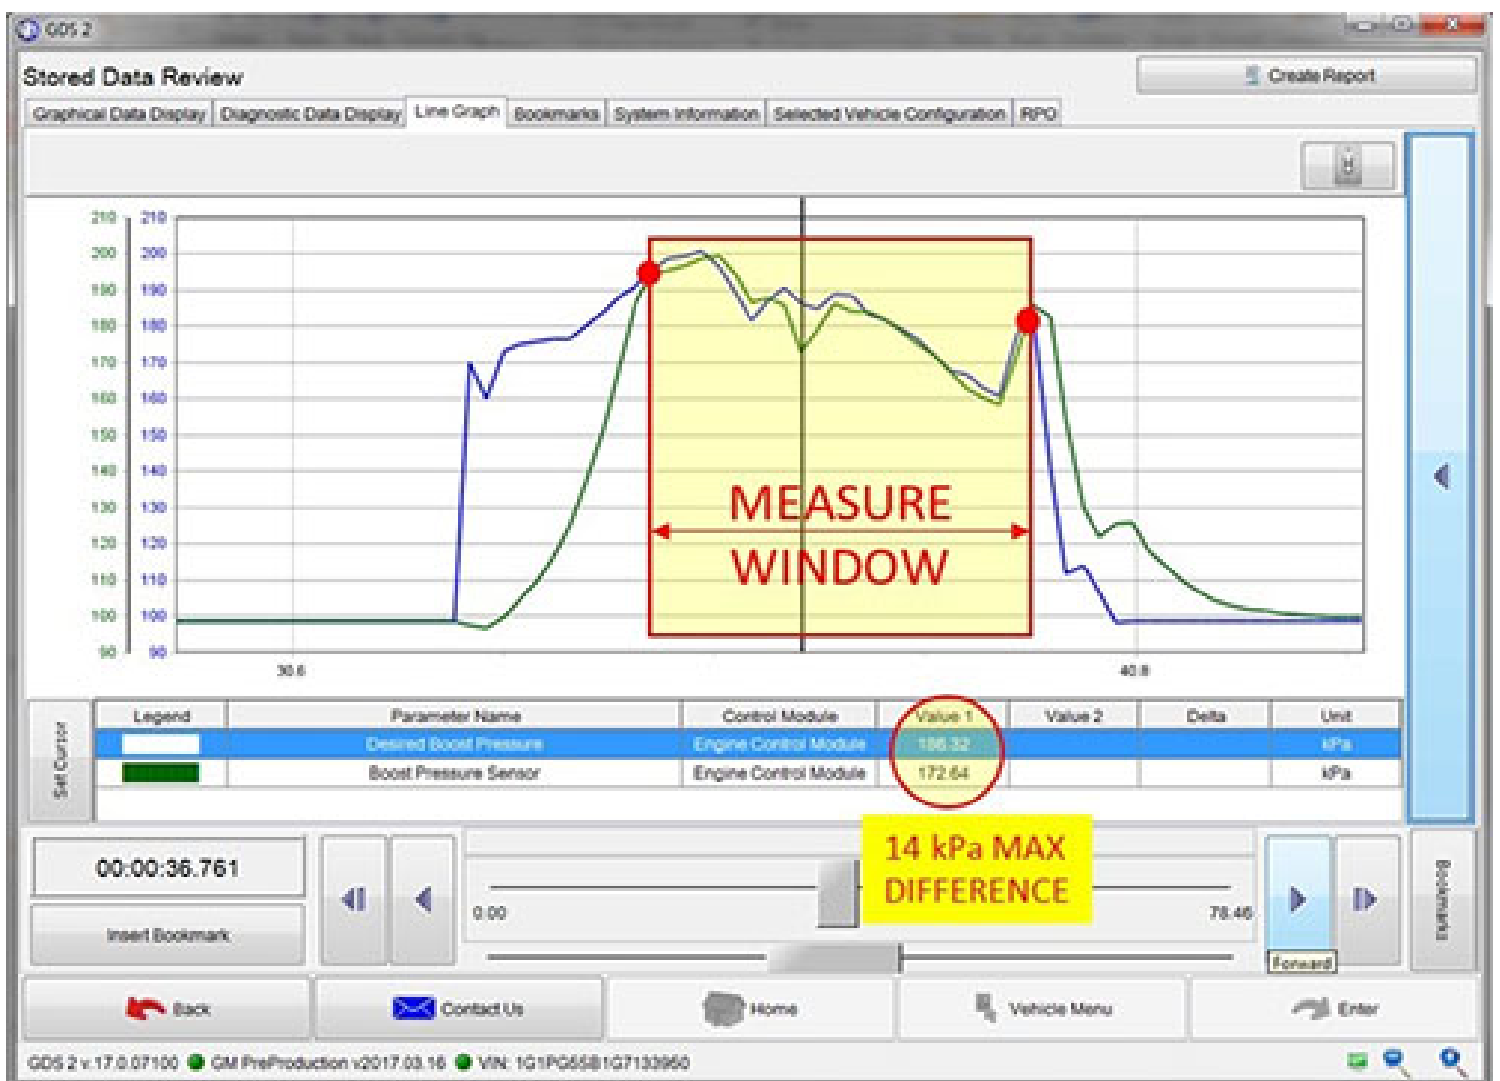
**Example of normal turbocharger wastegate operation:**

In this example, notice that the measure window begins once the Boost Pressure Sensor reading (Green) meets the Desired Boost Pressure reading (Blue) and ends when the APP is released per the testing instructions.

The Boost Pressure Sensor reading (Green) closely tracks the Desired Boost Pressure reading (Blue) indicating normal Turbocharger operation.
