Technical Service Bulletin

SUBJECT:		No: TSB-19-37-003	
UNABLE TO COMPLETE CODING PROCESS WHEN REPLACING THE EPS-ECU		DATE: May 2019	
		MODEL: 2018-19 Eclipse Cross	
CIRCULATE TO:	<input type="checkbox"/> GENERAL MANAGER	<input checked="" type="checkbox"/> PARTS MANAGER	<input checked="" type="checkbox"/> TECHNICIAN
<input checked="" type="checkbox"/> SERVICE ADVISOR	<input checked="" type="checkbox"/> SERVICE MANAGER	<input checked="" type="checkbox"/> WARRANTY PROCESSOR	<input type="checkbox"/> SALES MANAGER

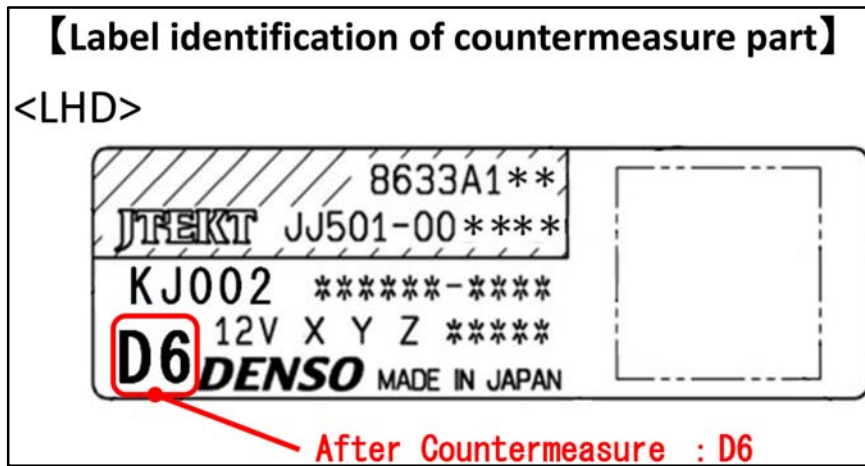
1. Verify the identification mark on the EPS-ECU is D0 (before countermeasure).
If the Identification mark is D6, then the EPS-ECU has the countermeasure software and reprogramming is not necessary.
2. Verify that the EPS-ECU has not already been updated to the latest S/W number in the table above.
If the EPS-ECU is at the latest level, reprogramming is not necessary.
