Technical Tip

91-18-13TT - MIB2 Infotainment System - Component Protection Activated (Displayed) On Radio Without Previous Repairs or After Cluster Replacement	
Market area	United States 444 Volkswagen of America, Inc. (6444)	
Brand	Volkswagen	
Date	November 2, 2018

MIB2 Infotainment System - Component Protection Activated (Displayed) on Radio without previous repairs or after Cluster Replacement

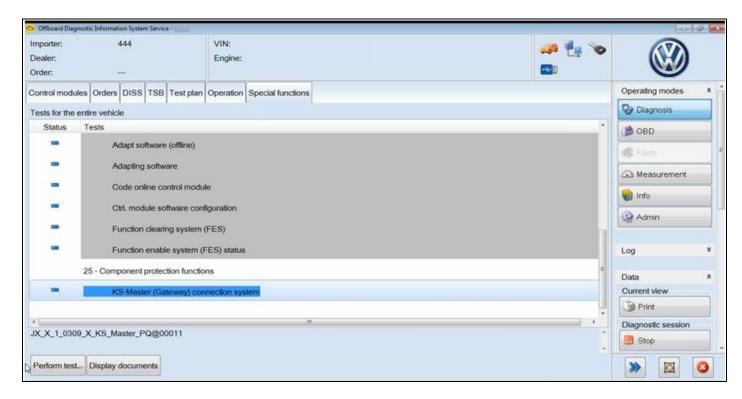
Figure 1

If component protection is activated (Figure 1) on the radio without any previous repairs or after replacing the instrument cluster, running the "KS-Master (Gateway) connection system" test plan will take the radio out of component protection.
