| Title | Diagnostic / Troubleshooting Procedures For Exhaust Gas Recirculation (EGR) System Components; Covers Most EGR System Diagnostic Trouble Codes (DTC), See List In Solution - US10, US10+OBD13, US14+OBD*, US17+OBD* With A Variable Geometry Turbocharger (VGT) |

| Mack Model | LEU , LR , MRU - TerraPro , TE - TerraPro , AN - Anthem , CHU - Pinnacle, Axle back , CXU - Pinnacle, Axle front , GR - Granite , GU - Granite , PI - Pinnacle , TD - Titan |

| Function Group | 293 EGR (Exhaust Gas Recirculation) |

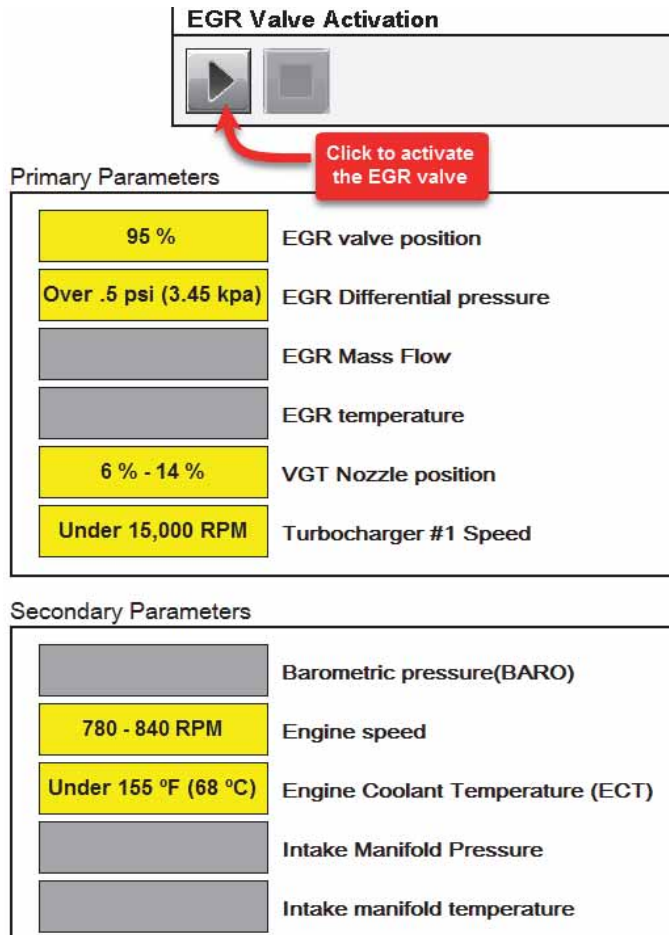
Screenshot : Should be taken with Conditions (in **YELLOW**) achieved and showing EGR valve at 95% just before the valve closes again OR the engine dies.

- **Turbocharger speed should drop below 15,000 RPM within 10 seconds of valve activation.**
- **If turbo speed does not change**, the EGR valve should be checked to confirm it is not stuck closed.

- **If turbo speed drops but remains above 20,000 RPM**, the EGR cooler is likely plugged.
 - A turbo speed reaction to EGR valve activation is a normal indicator of an operational EGR valve.

- The Venturi tube should also be checked to ensure it is free of blockage (Much less likely).
- **If turbo speed reacts as expected**, the EGR differential pressure sensor or EGR Temperature Sensor are the likely issue for High or Low Flow codes.

- Check for clogs or excessive condensation in the EGR sensor, sensor supply tubes, or Venturi tube.
 - Check for a non-plausible differential pressure value during valve activation.

- A negative value or low value, for instance .2 PSI (1.4 kPa) or less, at full valve activation is an indication of an EGR dP sensor and/or venturi tube issue.

- Check for a non-plausible EGR temperature value during valve activation.
 - A temperature reading below coolant temperature or higher than exhaust temperature is an indication of an EGR temperature sensor issue.
