Title	** Tech Tip ** - TT-019-2016 Automated Manual Transmission (AMT) Bearing And Gear Shaft Inspection
-------	--

Mack Model	AN - Anthem , CHU - Pinnacle, Axle back , CXU - Pinnacle, Axle front , GR - Granite , GU - Granite , PI - Pinnacle , TD - Titan
-------------------	---

Volvo Model	VNL , VNM , VNR , VNX , VAH , VHD , VT
--------------------	--

Transmission	AMT-F With Crawler Gears , AMT-F Without Crawler Gears , AMT-C , AMT-D , AMT-F , AMT-C , AMT-D , AMT-F With Crawler Gears , AMT-F Without Crawler Gears
--------------	---

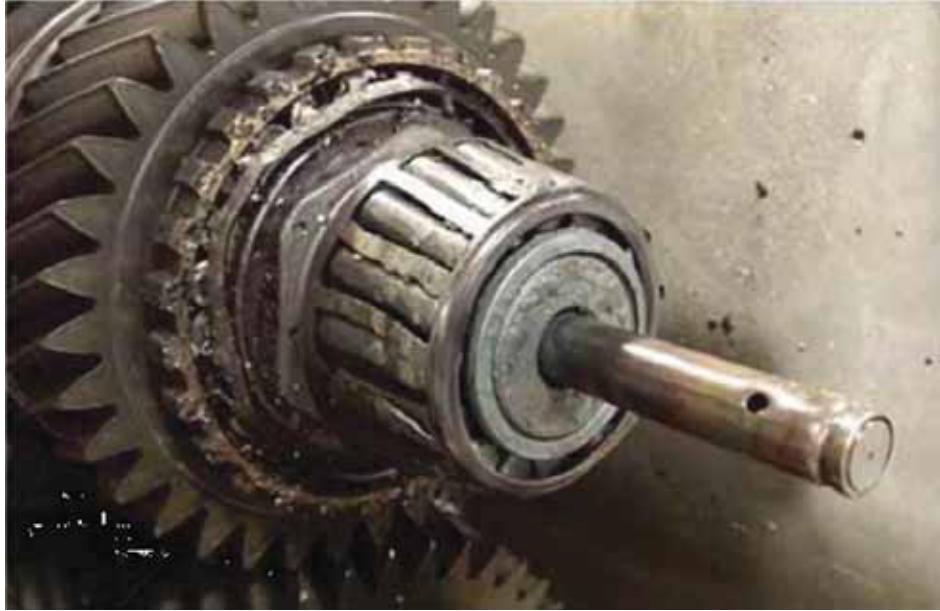
Towing Related Failure (Image 1)

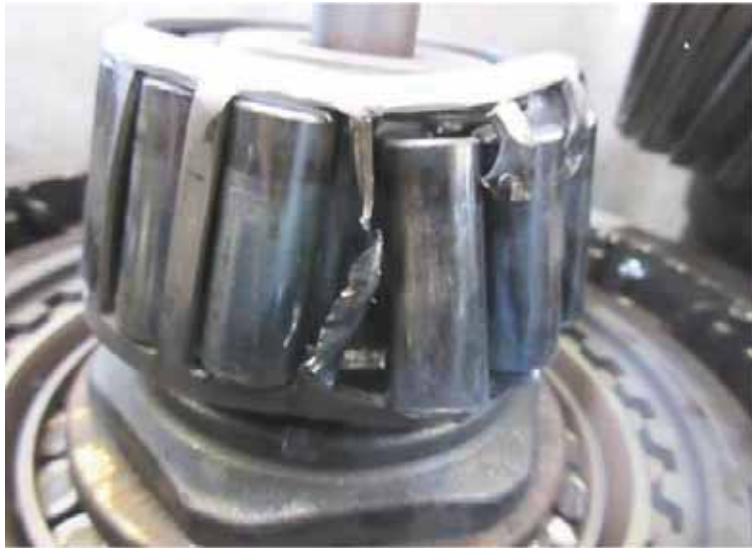
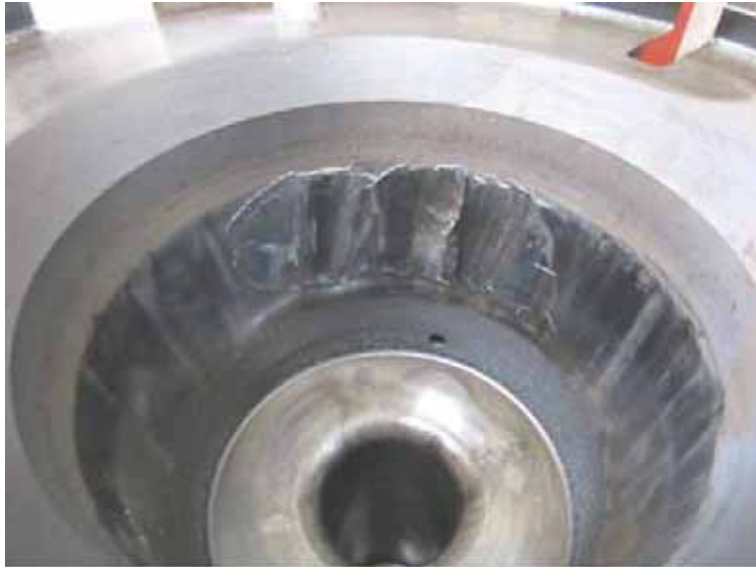
Towing Related Failure (Image 2)

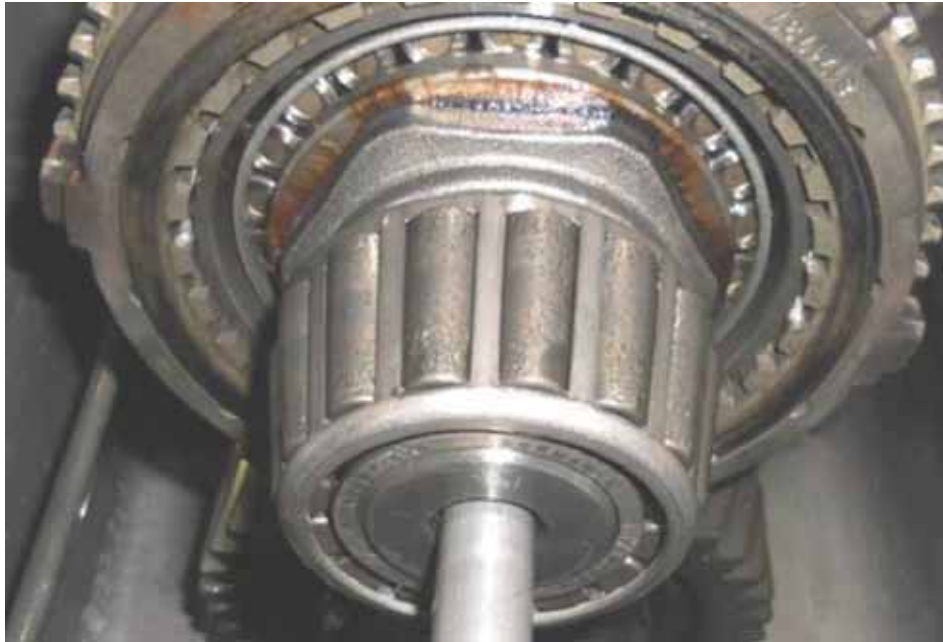
Spalled bearing failure (Image 3)

- 1.** The ridge in the input shaft. This is similar to what is seen in the spalled spigot bearing failure **image 3**.
- 2.** The DTC readout, as in the example below. The vehicle clock is incorrect however you can assume that the "Last Occurrence" has to be close to the readout day. In this example you can see that there had been main shaft codes for ~2 mo and split shift codes for ~3mo

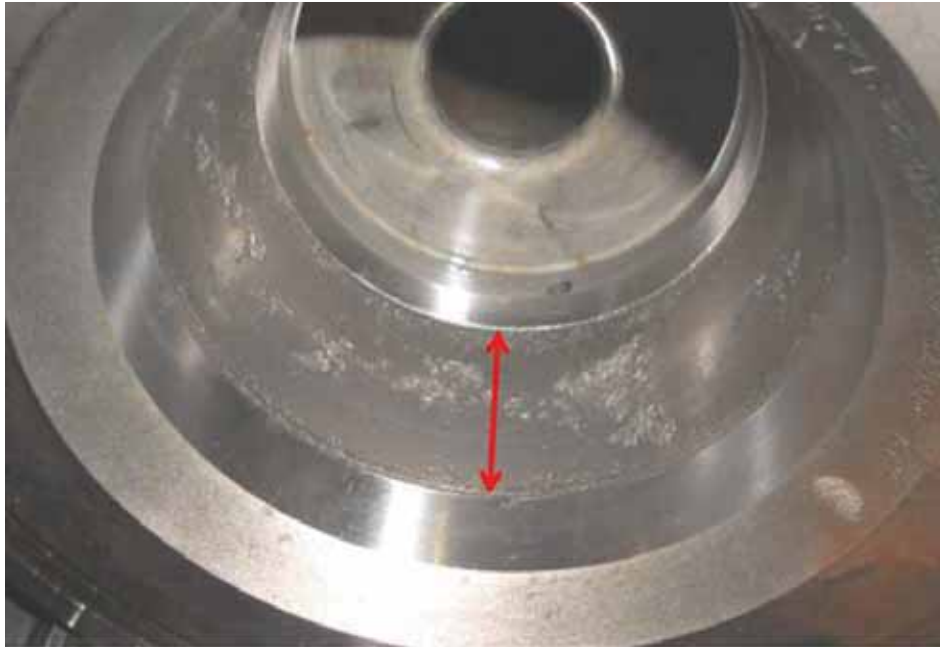
Spalled bearing race (Image 4)

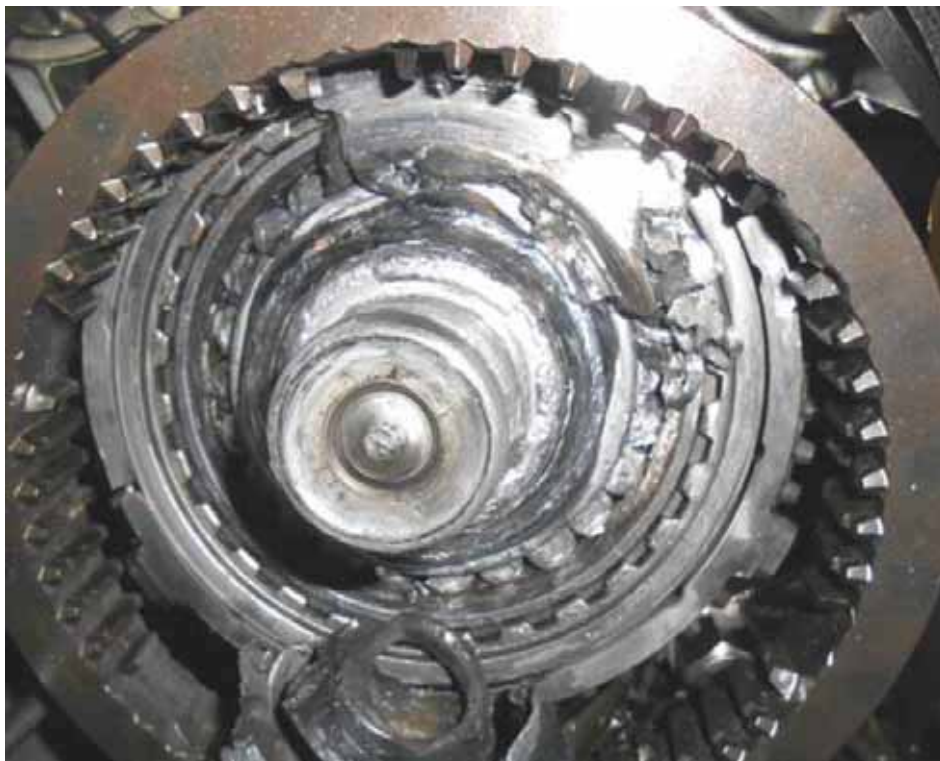
Spalled Bearing Failure (Image 5)

These images (5 & 6) represent a failure that went ignored for some time.

While the main shaft does not have evidence of heat as in the towing example (image 1), there are additional parts that have been affected:

- Contact with the main shaft nut
- Rollers missing and race worn down
- Oil distribution tube twisted off and closed
- P1 bearing damaged
- Split synchro ring broken

Clues that this may have been a spalled, or otherwise damaged, spigot bearing is:

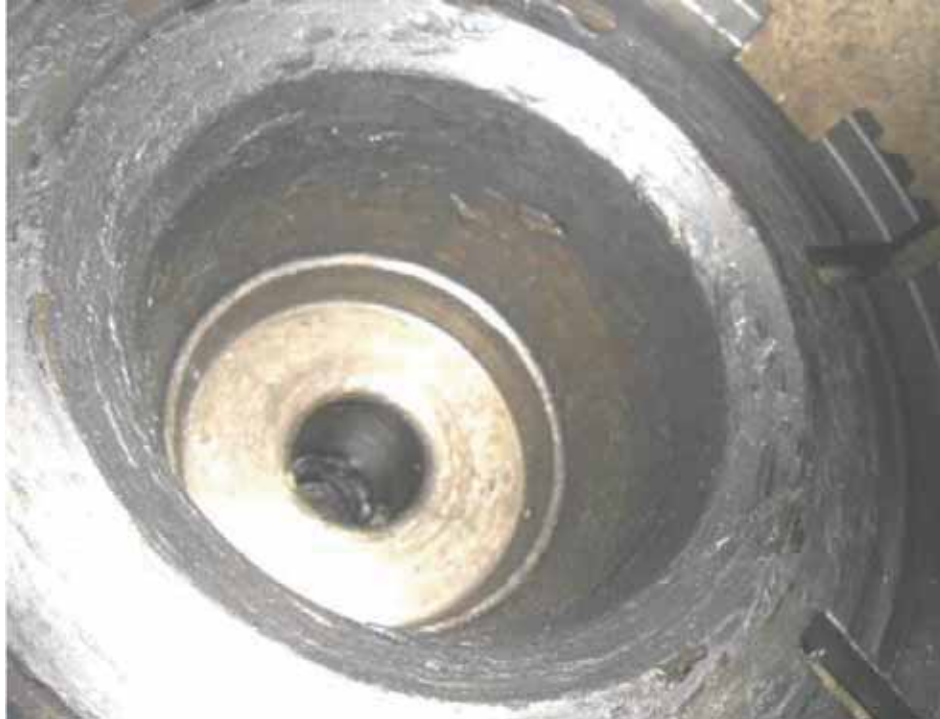
Spalled Bearing Race (Image 6)
