Service Information No. SI 52 001 19

C 400 X (K09, OCC19) Replacing Seat

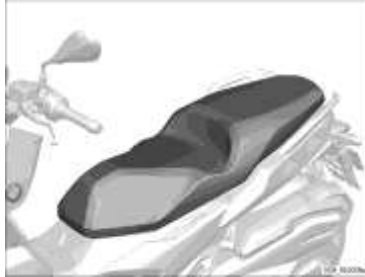
As a part of the ongoing quality analysis, BMW Motorrad has found that the seat does not fulfill the requirements with respect to waterproofness, whereby water can penetrate into the helmet holder.

Figure 1: Seat C 400 X

For affected vehicles prior to delivery or during the next workshop visit, the seat is to be renewed as per repair instructions 52 53 059 Renewing complete dualseat in AIR (Aftersales Information Research).
