Technical Service Bulletin

30 Transmission leak from service opening of the lower bellhousing

30 19 25 2053597/3 June 25, 2019. Supersedes Technical Service Bulletin Group 30 number 19-24 dated May 15, 2019 for reasons listed below.

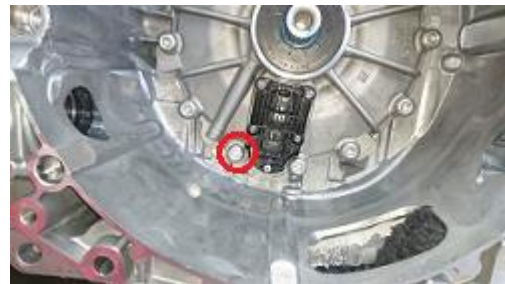
1. Remove the lower bolt of the cover on the passenger's side of the plastic cover (Figure 1 and Figure 2).

Figure 1. Bolt location.

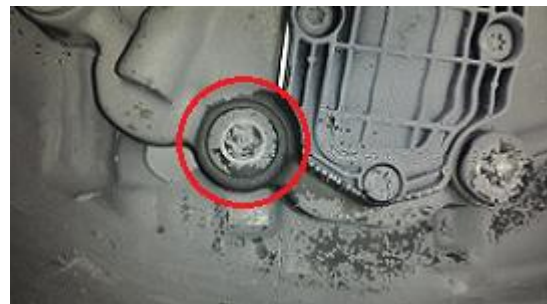
Leaking through the bolt holes of the clutch cover.

Figure 2. Leak location.

2. If there is oil residue in the bolt hole, continue with this TSB repair. If there is no oil residue in the bolt hole, create an Audi Technical Assistance Center contact with pictures of the leak and a diagnosis log attached. Then contact Audi Technical Assistance Center for diagnosis assistance.

1. Remove all bolts of the clutch cover.
2. Clean the bolt holes.
3. Install 12 new bolts for the clutch cover with the part number WHT 002 459 C:
 - Tightening torque: 12Nm + 90°.
 - The tightening sequence is a diagonal pattern as described in the repair manual.
4. Reinstall the dual mass flywheel into the transmission per the repair manual.
5. Reinstall the transmission into the vehicle per the repair manual.
6. Check and adjust the transmission ATF level.
7. Road test for proper operation.
