Technical Service Bulletin

Topic	Night vision camera - Washer jet leaking
Market area	Bentley: worldwide (2WBE),Hongkong-Macau (5HK)
Brand	Bentley
Transaction No.	2051045/3
Level	EH
Status	Released for publishing
Release date	May 20, 2019

Bentayga and New Continental GT

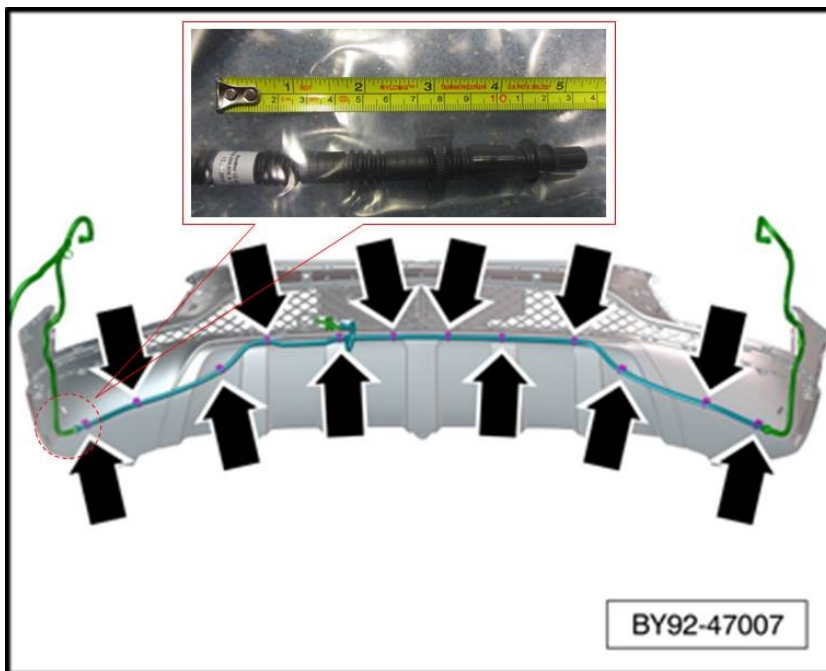
The date codes are located on a label usually located on the left or right hand side of the hose and also embossed onto the Night vision camera washer jet carrier as detailed within the onward instructions

- Remove the front bumper moulding. Refer to "Front bumper moulding - To remove and fit" – Repair Group 63 in Elsa pro.
- Replace the headlamp / night vision camera washer hose assembly (*fixed to the bumper moulding*) with a new assembly. Refer to "Headlamp washer hoses - To remove and fit" – Repair Group 92 in Elsa pro.
- Provide a clear high resolution photograph of the manufacturing date (*circled*) on the label as shown in Figure 1

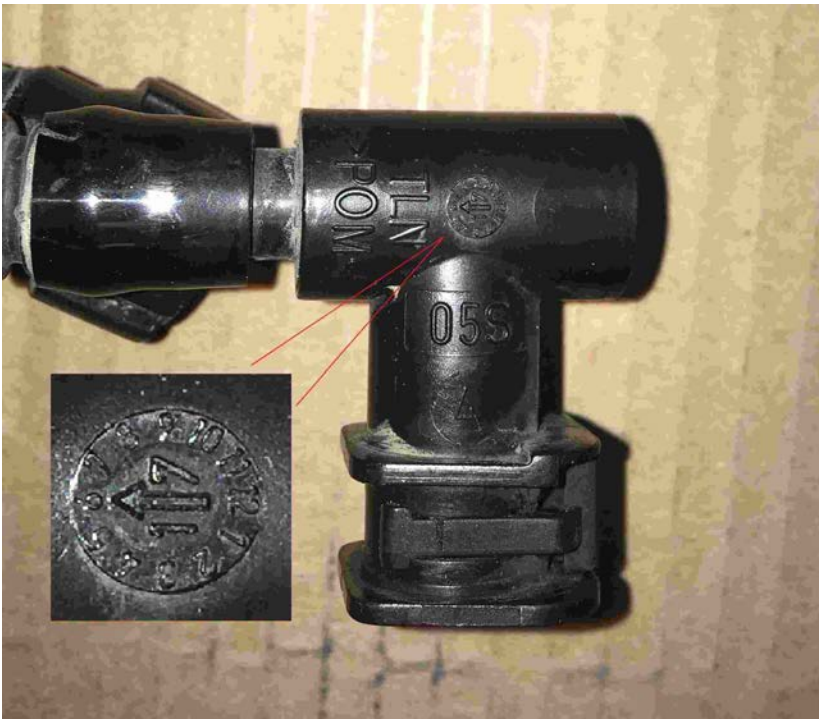
Figure 2

□ **The date stamp (*inset*) is situated on the underside of the jet carrier elbow as shown and is very small.**

The arrow refers to the month of manufacture and the two numbers either side of the arrow represents the year of manufacture.

- Provide a clear high resolution photograph of the embossed manufacturing date (*inset*) on the wash jet carrier as shown in Figure 2.
- Photographs to be sent on an Information Only DISS

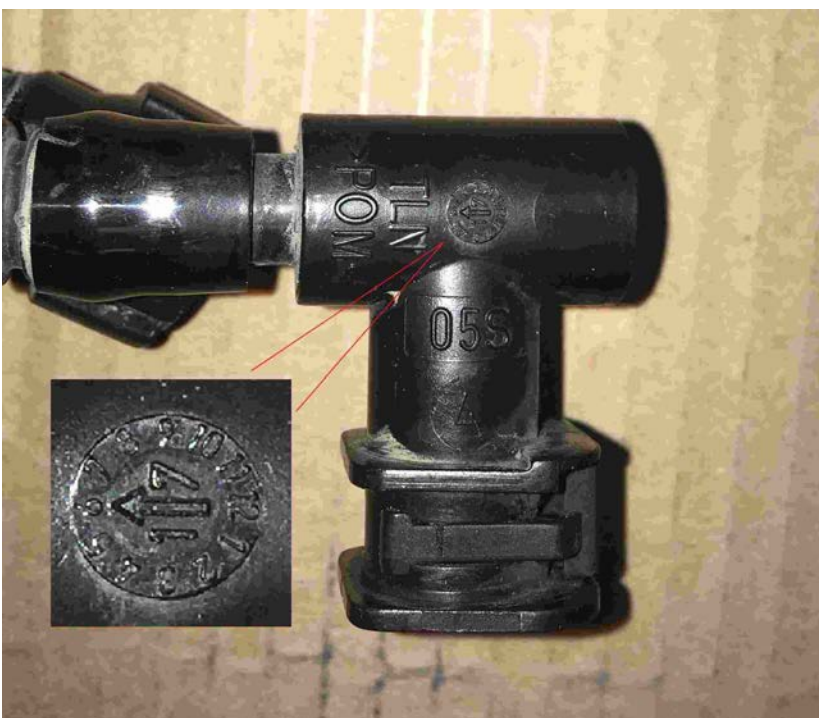
□
The date stamp (*inset*) is situated on the underside of the jet carrier elbow as shown and is very small.

The arrow refers to the month of manufacture and the two numbers either side of the arrow represents the year of manufacture.

- Provide a clear high resolution photograph of the embossed manufacturing date (*inset*) on the wash jet carrier as shown in Figure 6
