## Field campaign

<b>Topic</b>	Front camera parameters (SC19/04)
<b>Market area</b>	Bentley: worldwide (2WBE),Hongkong-Macau (5HK)
<b>Brand</b>	Bentley
<b>Transaction No.</b>	2053347/2
<b>Campaign number</b>	EB18
<b>Note</b>	
<b>Type</b>	
<b>US code</b>

### Bentayga

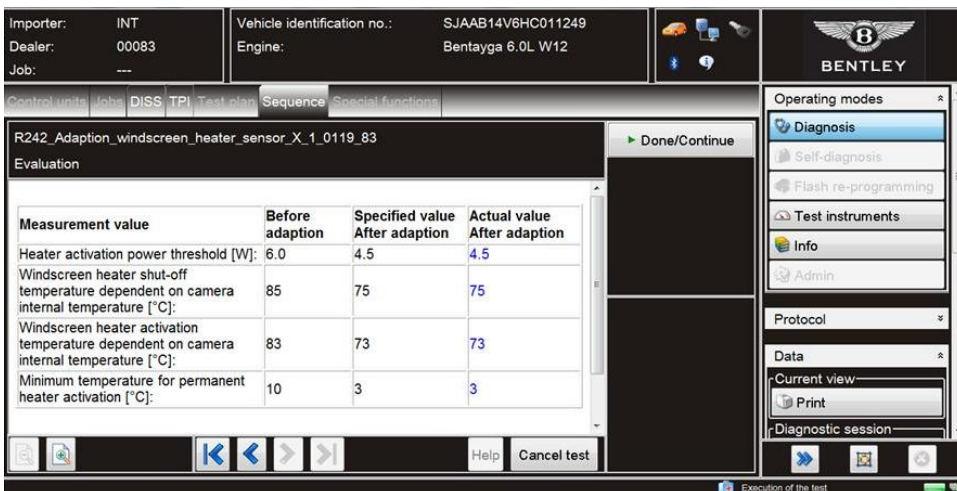
Figure 6

On a limited number of Bentayga vehicles, the heating parameters for the front camera may have been set incorrectly.

Now select and run the test, the heating parameters for the front camera will be adjusted. Ensure the new values in the 'Actual value after adaption' column are stored exactly as below (Figure 6).
