Technical Service Bulletin

Topic	W12 - Oil leak from engine
Market area	Bentley: worldwide (2WBE),Hongkong-Macau (5HK)
Brand	Bentley
Transaction No.	2053350/2
Level	EH
Status	Released for publishing
Release date	May 17, 2019

Oil leak from engine area.

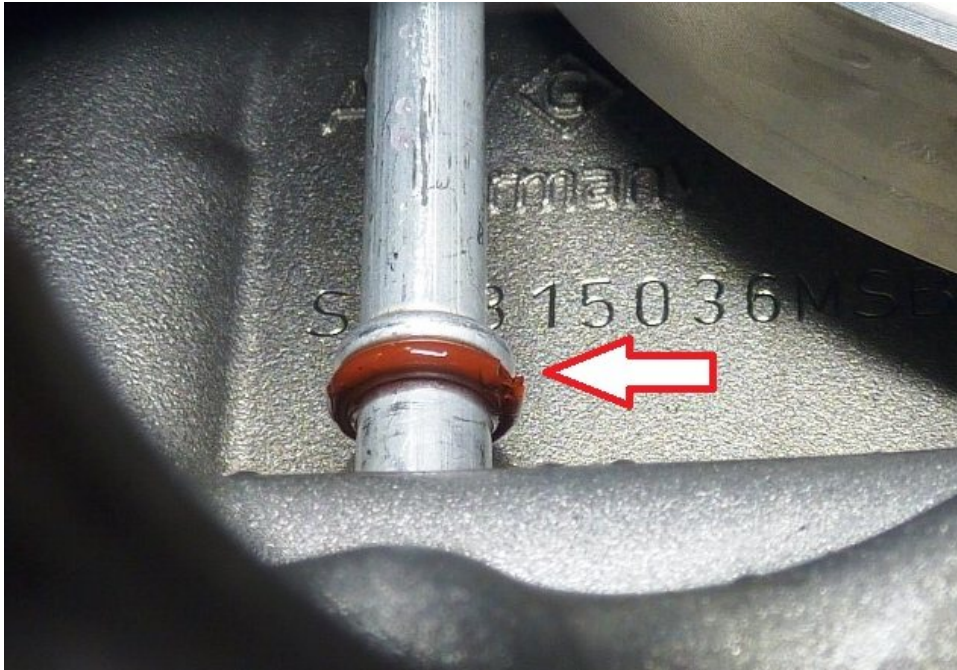
The breather return line and the oil dipstick tube O-rings can split causing an external oil leak.

This can be misdiagnosed as the engine sump leaking.

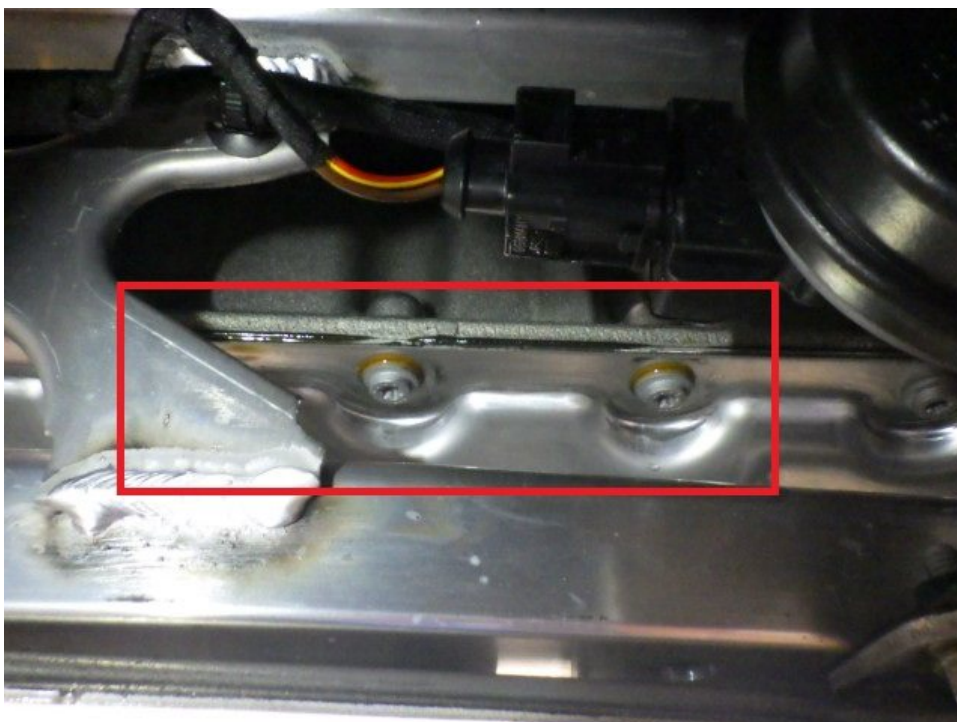
Figure 1

If an engine oil leak is found from the area shown in Figure 1, check the O-rings of both the breather return line and the dipstick tube for leakage. The oil can run down the engine and settle on the sump leading to misdiagnosis, Figure 1.

Should either of the O-rings be damaged or leaking replace according to ETKA.

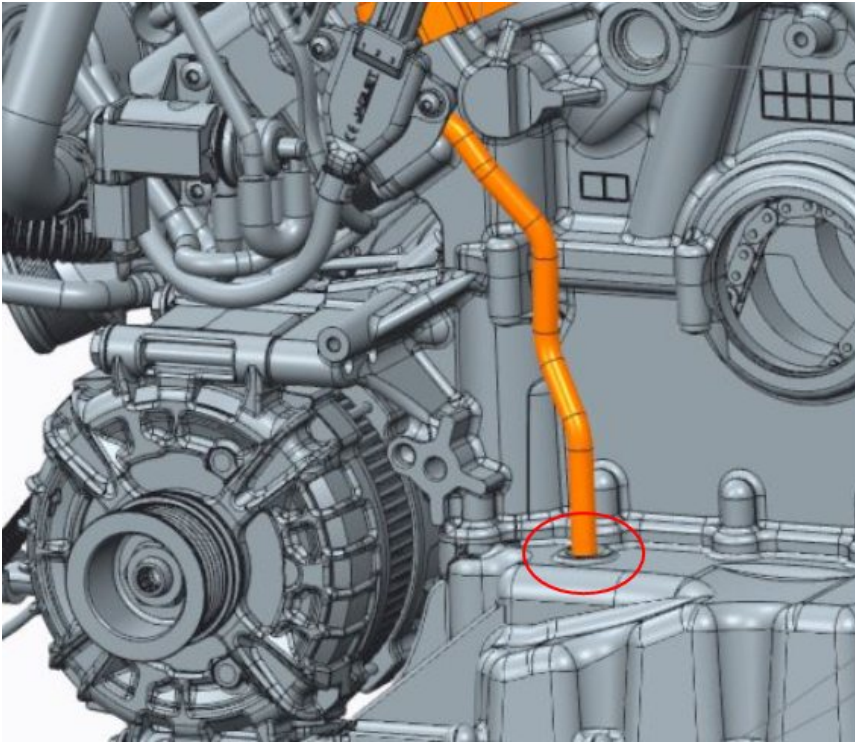
Figure 2

1. Firstly check the breather return line for signs an oil leak in area highlighted in Figure 2. Should a leak be evident, remove the tube and check the O-ring for damage.

Power unit → Engine lubrication → 6.0 L W12 TSI → Oil breather system return line – To remove and fit

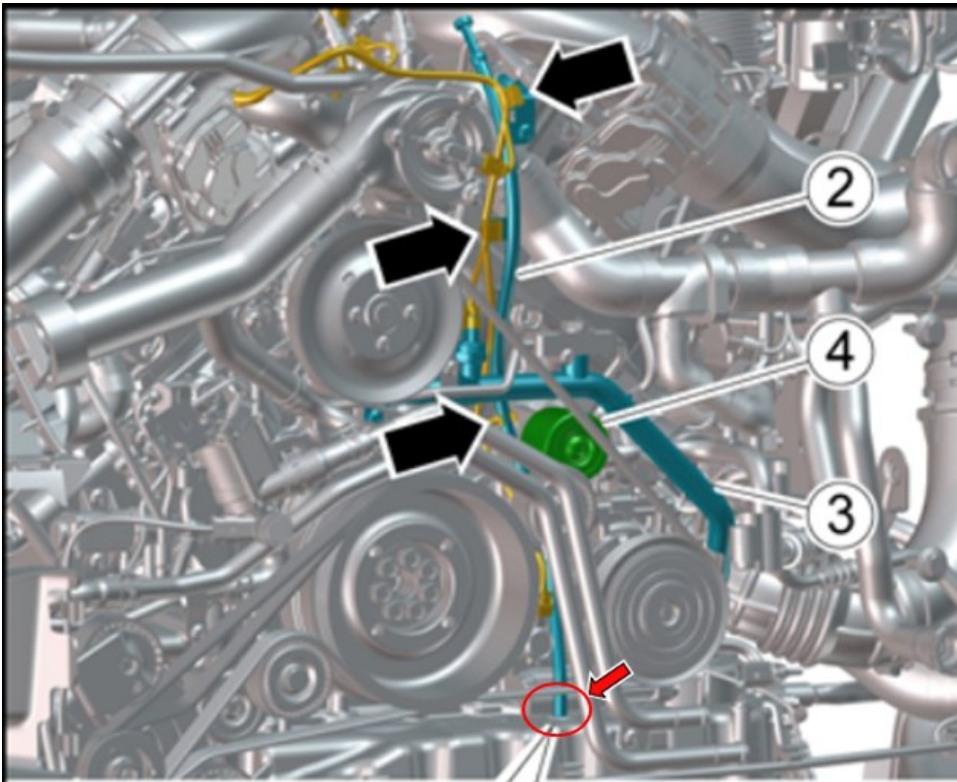
Figure 3

2. Check the dipstick tube for signs of an oil leak in area highlighted in Figure 3. Should a leak be evident, remove the dipstick tube and check the O-ring for damage.

Power unit → Engine lubrication → 6.0 L W12 TSI → Assembly dipstick and tube – To remove and fit
