Technical product information

Topic	Bullseye air outlets - chrome finisher detached
Market area	Bentley: worldwide (2WBE),Hongkong-Macau (5HK)
Brand	Bentley
Transaction No.	2054084/1
Level	EH
Status	Approval
Release date

Bentayga

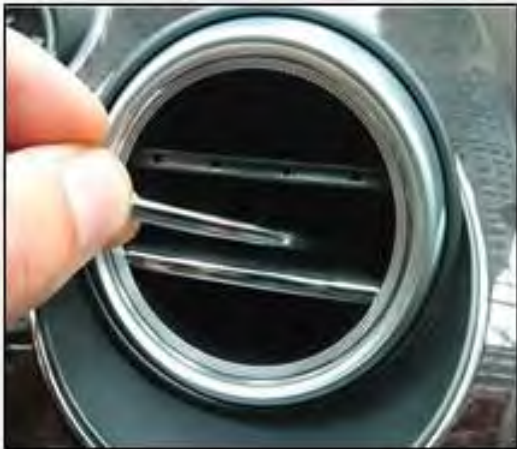
Air vent chrome finisher has detached from vane.

It is possible that using aftermarket clip on devices such as mobile phone holders, air freshener holders or chewing gum dispensers may result in the chrome air vent finisher becoming detached from the vane.

Please advise the Customer that the use of aftermarket clip on devices is not recommended and continued use may result in repeat failures. Damage caused by the use of aftermarket clip on devices will not be covered under vehicle warranty.
