Technical Service Bulletin

Topic	Noises from Panoramic sun roof
Market area	Bentley: worldwide (2WBE),Hongkong-Macau (5HK)
Brand	Bentley
Transaction No.	2054210/2
Level	EH
Status	Released for publishing
Release date	May 17, 2019

Bentayga

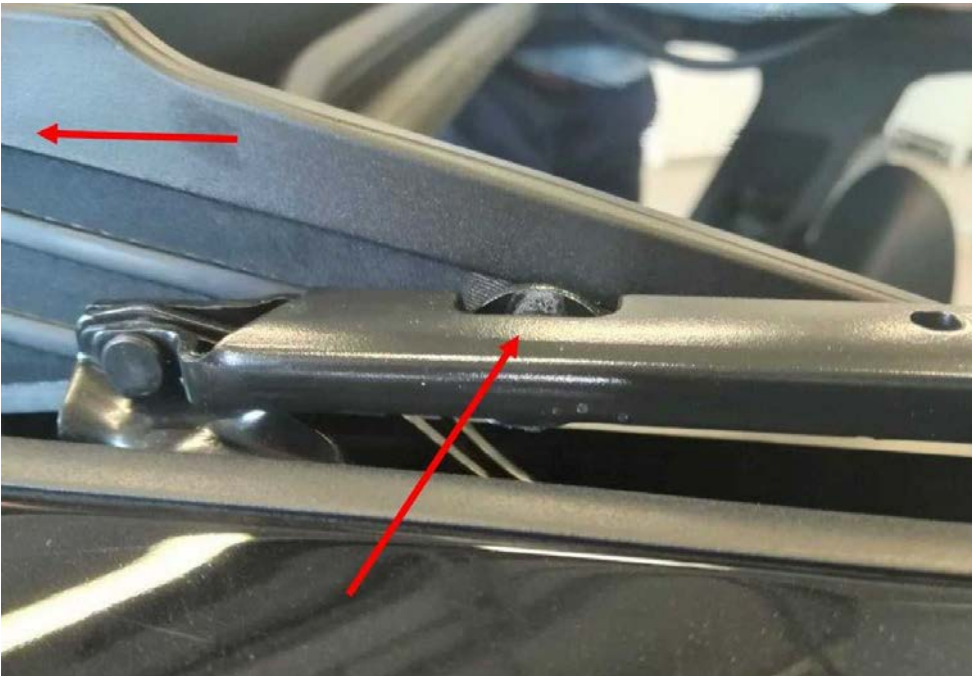
2) The above illustration shows the left mechanical system. The upper left arrow points to the driving direction. The lower arrow points to the first mounting point of the glass panel.

- For a better access to the points to be greased move the mechanical system (slightly) rearwards
- Apply grease spray **G 060 567 A2** to the points shown within the onward instructions

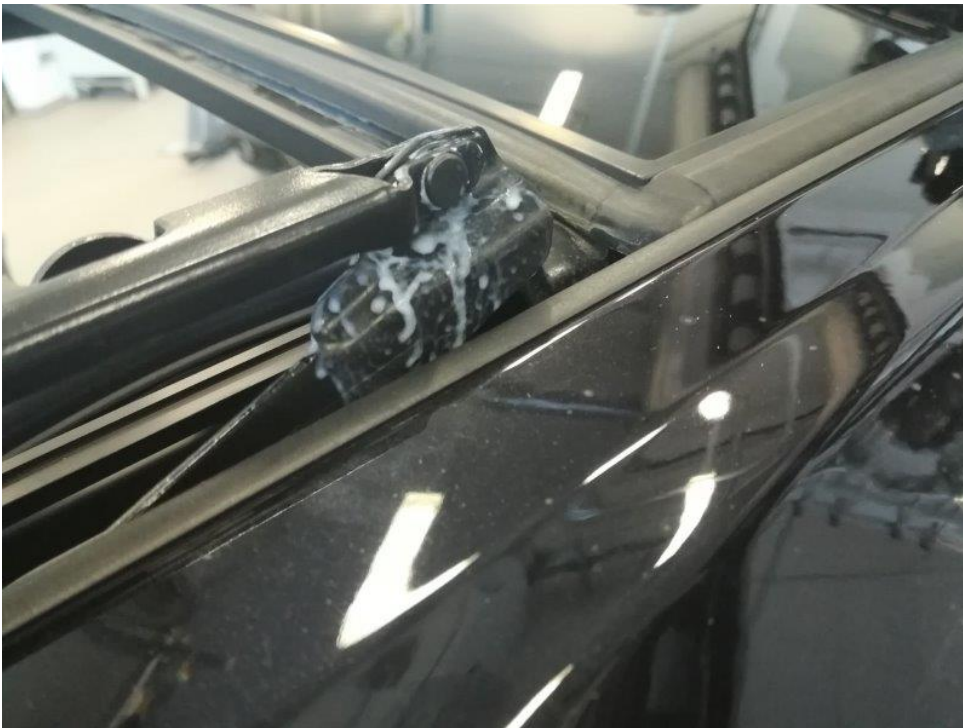
- The above illustration shows the point after the lubrication.
