Service Bulletin

Bulletin No.: 16-NA-380

Subject: Diagnostic Tip for SES Lamp Illuminated, Excessive Smoke from Tail Pipe, DTC P2002, P226D or P244A Set

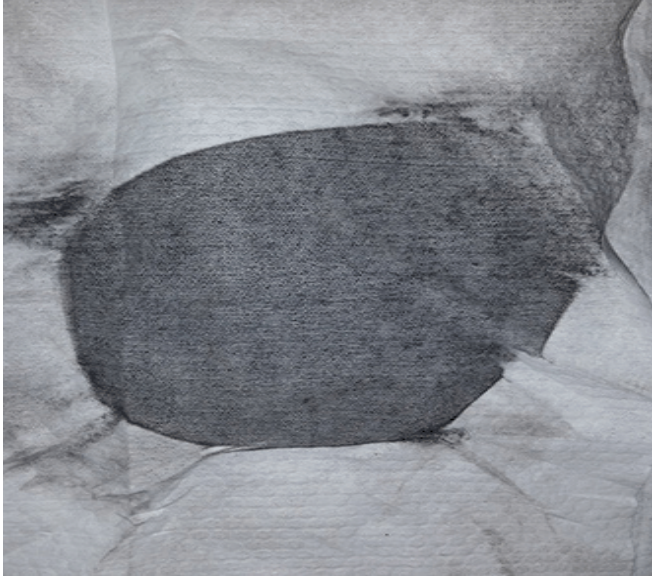
4622615

- A failed exhaust soot flow test will show excessive soot particulates on the cheese cloth or equivalent. Refer to the graphic above.
- A passing exhaust soot flow test will show no, or very minimal, signs of soot particulates.

If the vehicle set P2002, P226D or P244A and no other codes, and SI diagnostics leads to DPF replacement, use the cheese cloth test to confirm if the DPF needs to be replaced.
