Service Bulletin

Bulletin No.: 18-NA-020

Subject: Malfunction Indicator Lamp Illuminated with DTC P0300 and/or P0299/P2227 Set

Service Procedure Equinox, Terrain

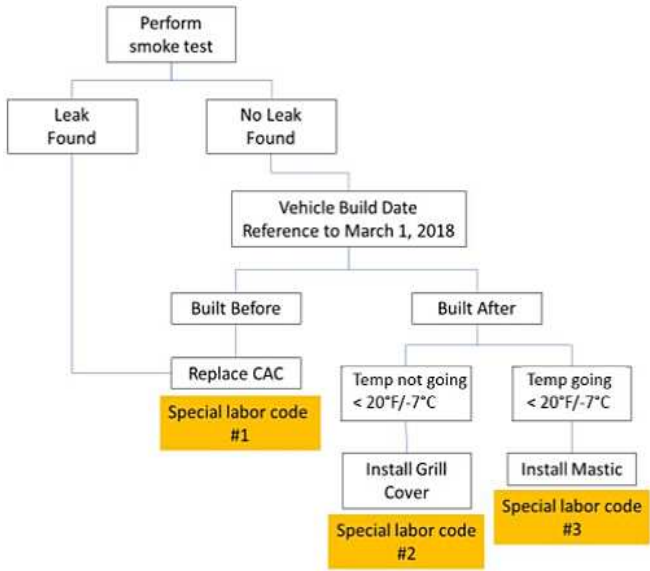
Flow Chart Based on Conditions

Involved Region or Country	North America and N.A. Export Regions
Condition	Some customers may comment on a malfunction indicator lamp illuminated. During diagnosis, a technician may find DTC P0299, P2227, or P0300 set/stored.
Cause	This condition may be caused by a moisture build up inside the charge air cooler. Long drives through rainy conditions and/or high humidity conditions (heavy fog) can cause moisture to collect in the charge air cooler. A heavy acceleration can draw moisture into the engine causing DTC P0300. In cold temperatures, ambient and PCV moisture can freeze in the charge air cooler, restricting flow, and causing DTC P0299 and/or P2227.
Correction	Perform a smoke leak test of the charge air cooler, then follow the repair steps in the appropriate Service Procedure below, depending on the build date and vehicle outside temperature experience. Note: Deadener material covering is only to be used in northern states or provinces where temperatures are consistently 20°F/-7°C or less.

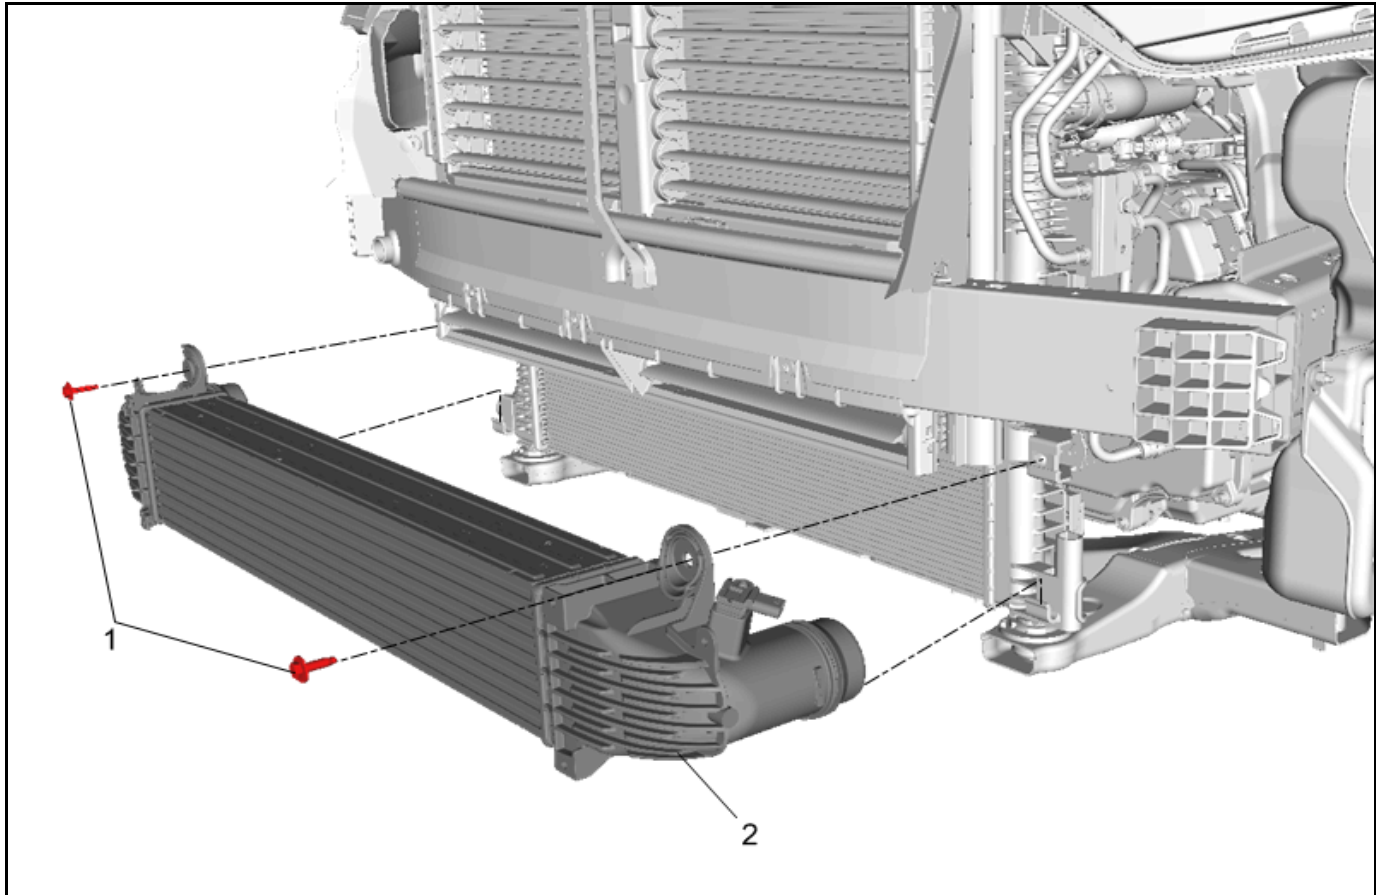
4597334

1. Perform a smoke leak test of the charge air cooler.

- If a leak is determined, replace the charge air cooler with the newly designed part. Refer to *Charge Air Cooler Replacement* in SI.
- If there is NO leak, but a P0300, P0299 and/or P2227 are present, **AND the vehicle was built ON or BEFORE March 1, 2018**, then replace the charge air cooler with the newly designed part. Refer to *Charge Air Cooler Replacement* in SI.
- If there is NO leak, but a P0300, P0299 and/or P2227 are present, **AND the vehicle was built AFTER March 1, 2018**, refer to SI for further diagnosis.
