SRS fault message in instrument cluster and/or SRS/airbag indicator lamp lights up

Topic number	LI91.60-N-069828
Version	1
Function group	91.60 Airbag, pedestrian protection
Date	05-21-2019
Validity	Model 907
Reason for change	
Reason for block

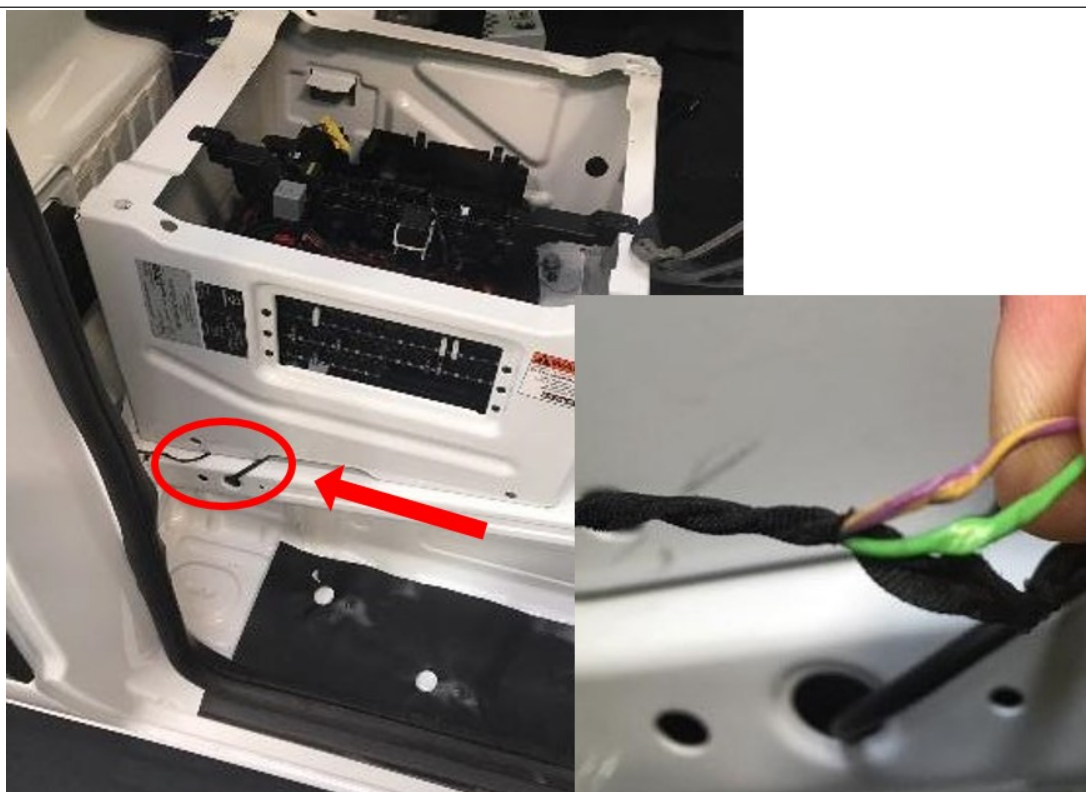
01.jpg:

Attachments	
File	Description
01.jpg	Pinched cable

1. Connection of airbag control unit N2/5 (Supplemental Restraint System (SRS) control unit).
2. Jammed/pinched lines in area of seat box (see picture 01).

2. Check electric lines of squibs for seat belt tensioner R12/1 (squib for driver seat belt tensioner), R12/2 (squib for front passenger seat belt tensioner) and/or R12/32 (squib for center front passenger seat belt tensioner) in area of seat box. If these are pinched or chafed, repair them and route without chaffing again (see picture 01).
