## MBUX multimedia system: Navigation and/ or Satellite Radio not selectable/not available

Topic number	LI82.85-N-069752
Version	3
Function group	82.85 Navigation and Communication system (CNS, ICS, COMAND, FleetBoard)
Date	05-21-2019
Validity	Model 907 with code E1A (MBCONNECT - 5)/ E1C (AUDIO 25)/ EJ9 (COMAND ONLINE)
Reason for change	Title, validity & remedy changed!
Reason for block

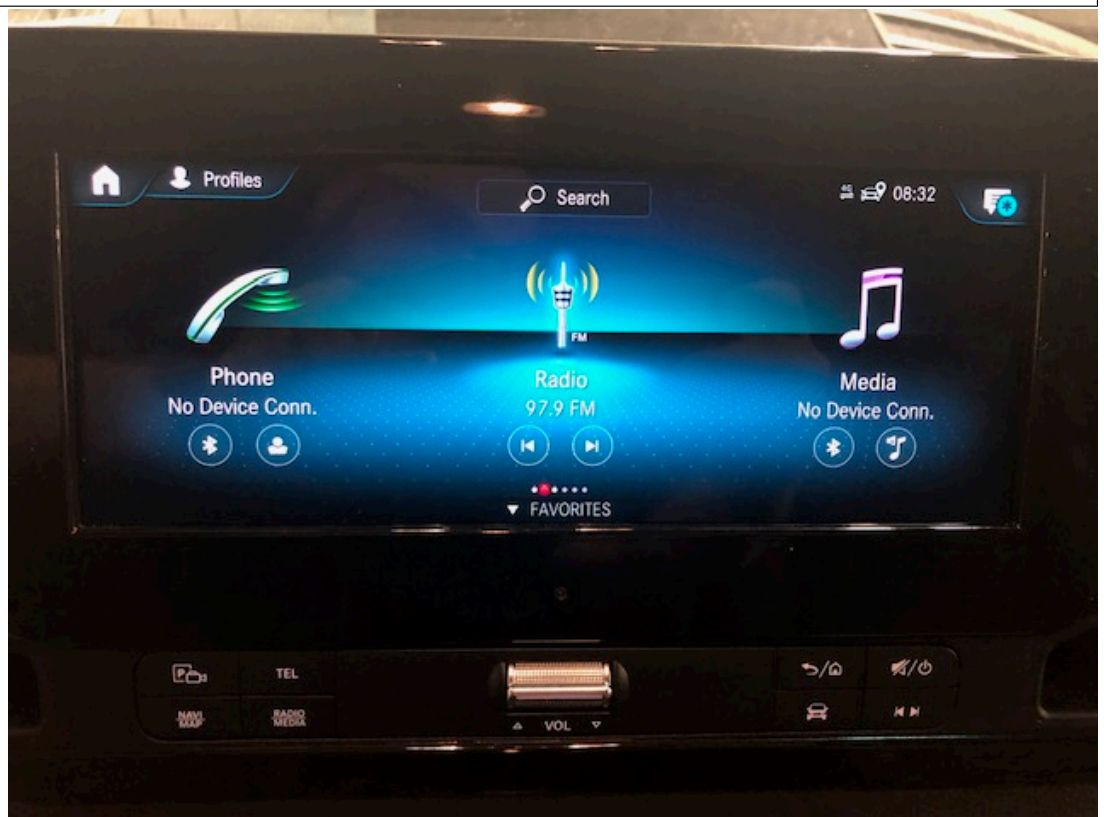
MBUX menu.jpg:

Navigation not available in source menu and Traffic Sign Assist inoperative

Head unit software (component A26/17)

**IMPORTANT:** Do not replace any components!!!

1. Perform manual commissioning of head unit
2. Perform teach-in process of head unit -> Adaptations / Teach-in processes / Special function  
Request a password via XSF Diagnosis Support.
